MIRABAY SEAWALL LITIGATION

- April 18, 2012

WHY IS IT TAKING SO LONG?

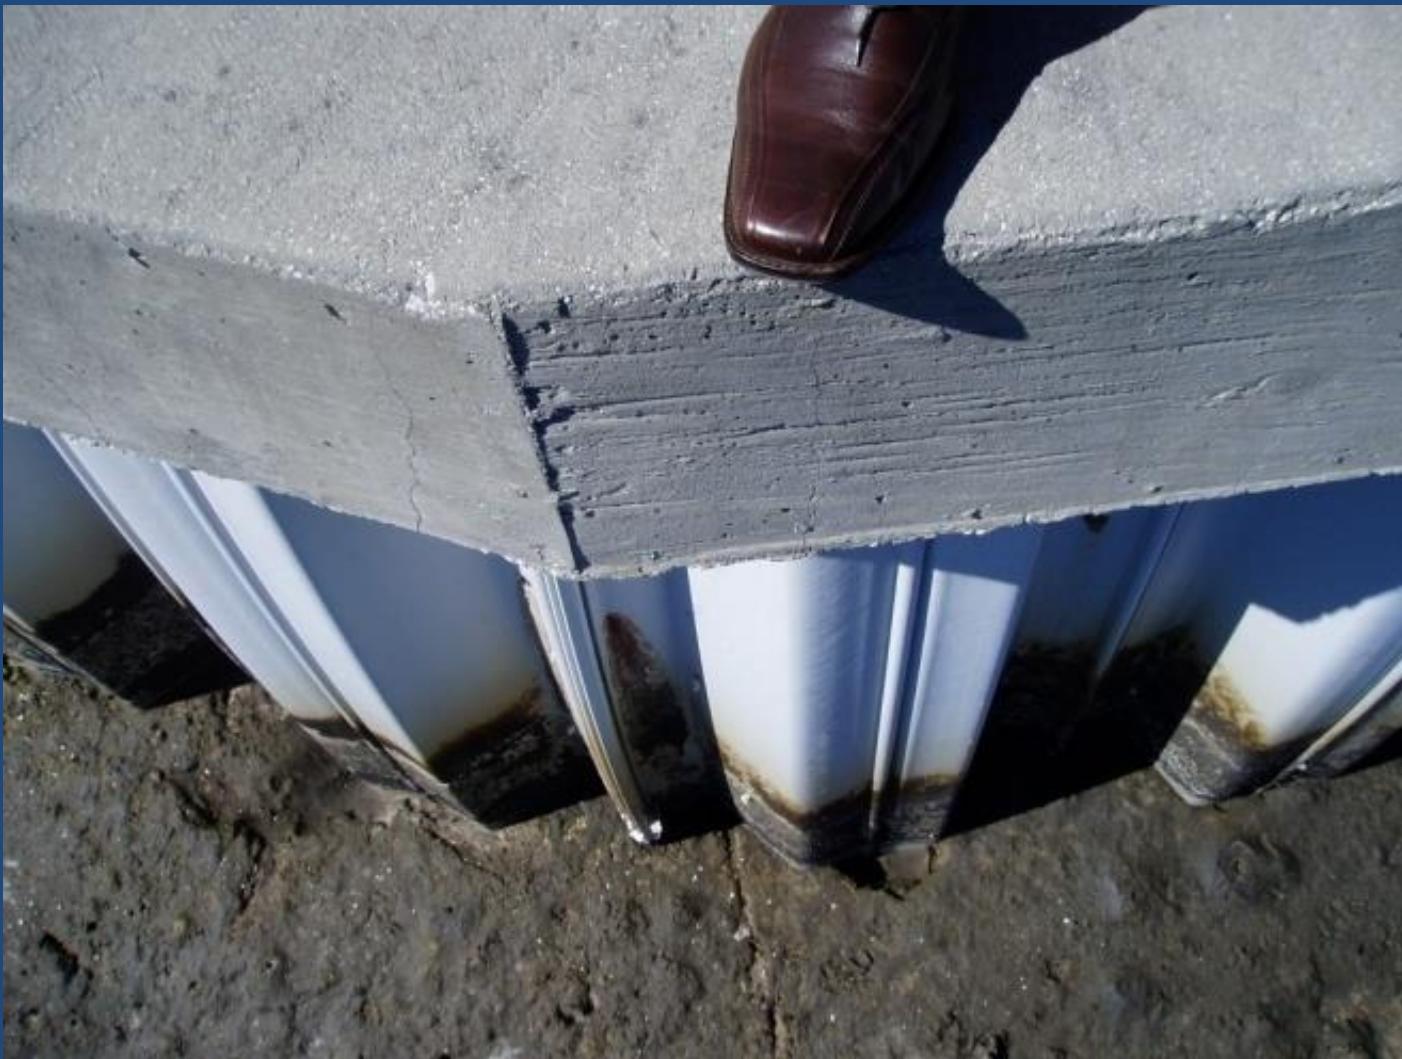
BOWING

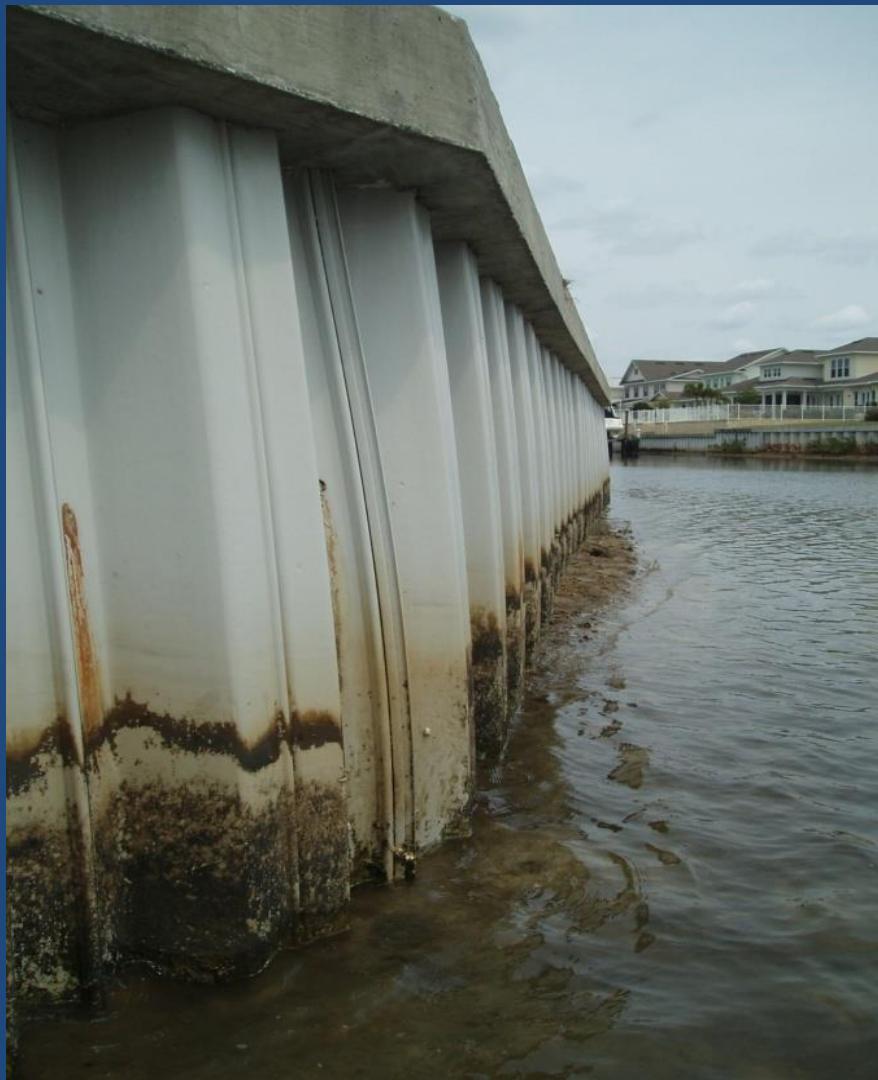
BOWING

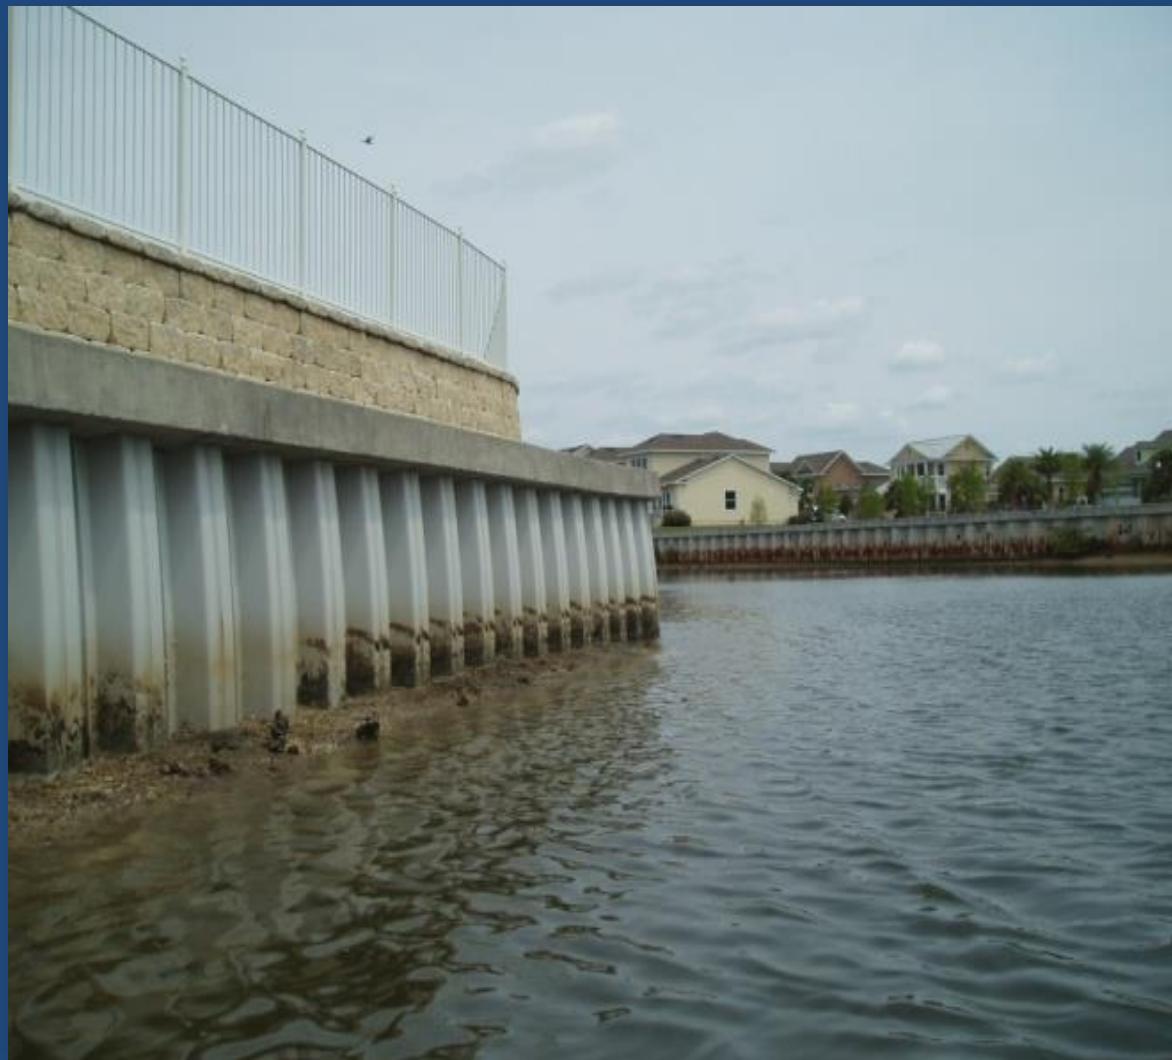
TOE KICK

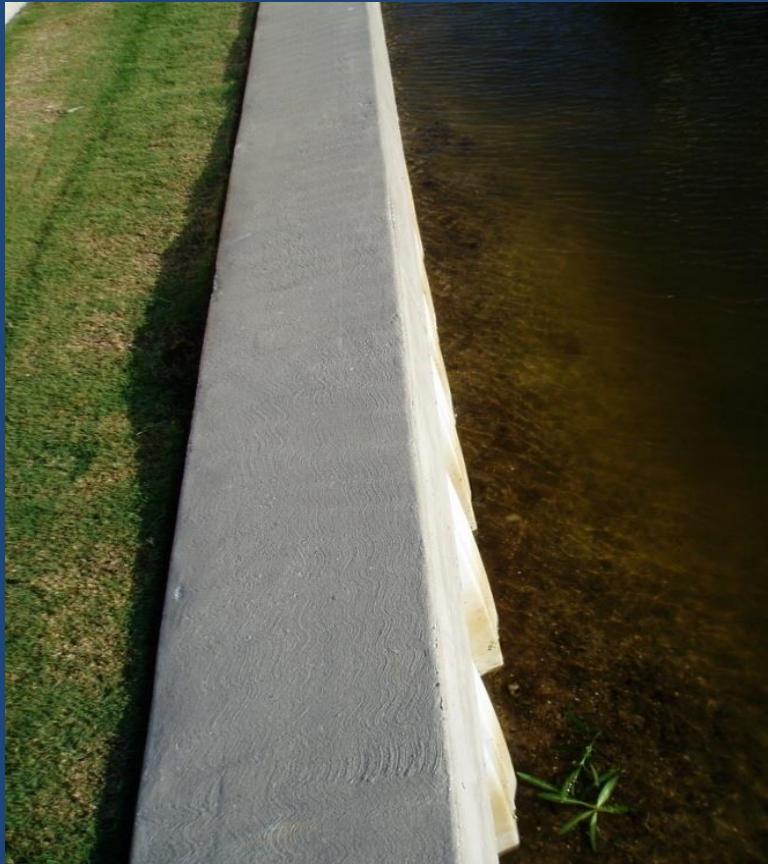
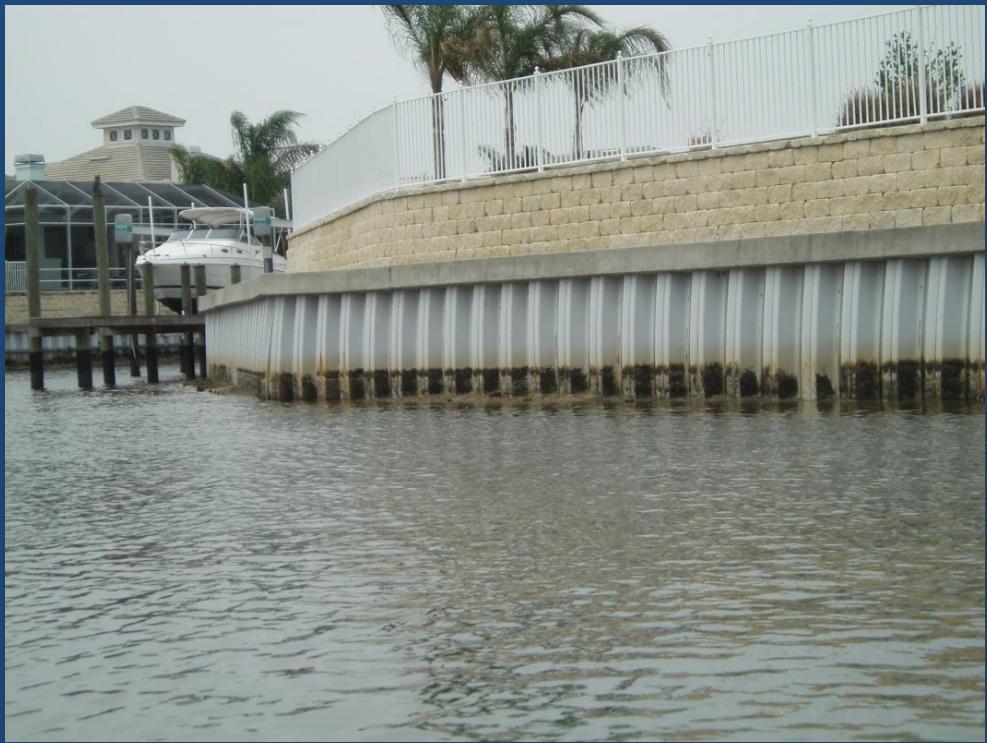
TOE KICK

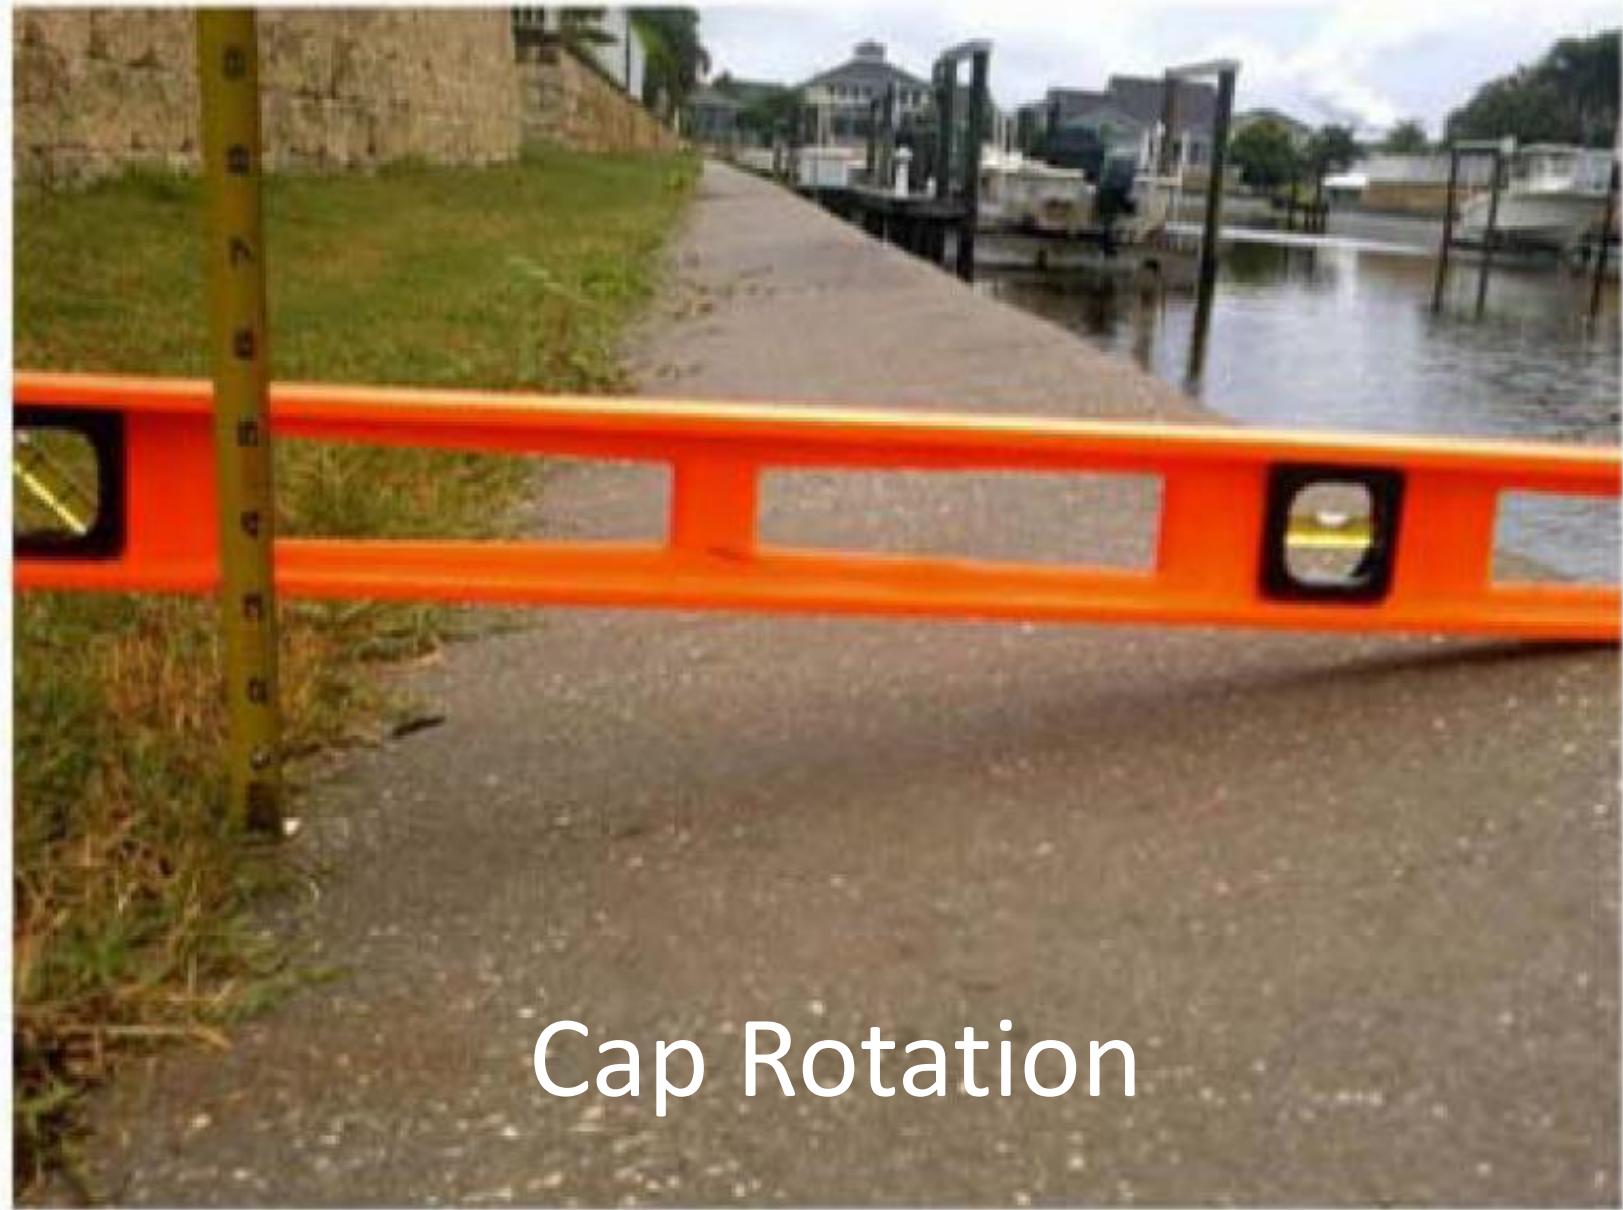
Cap Rotation

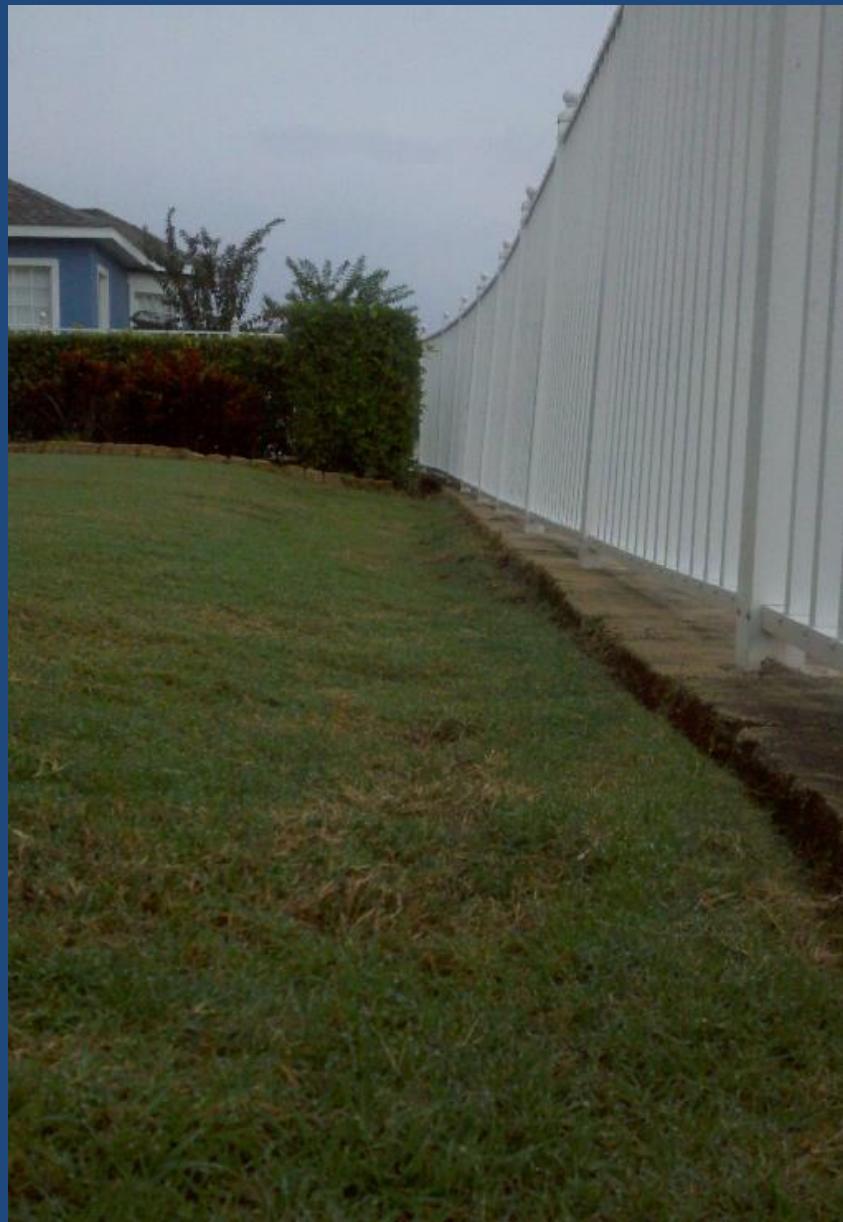
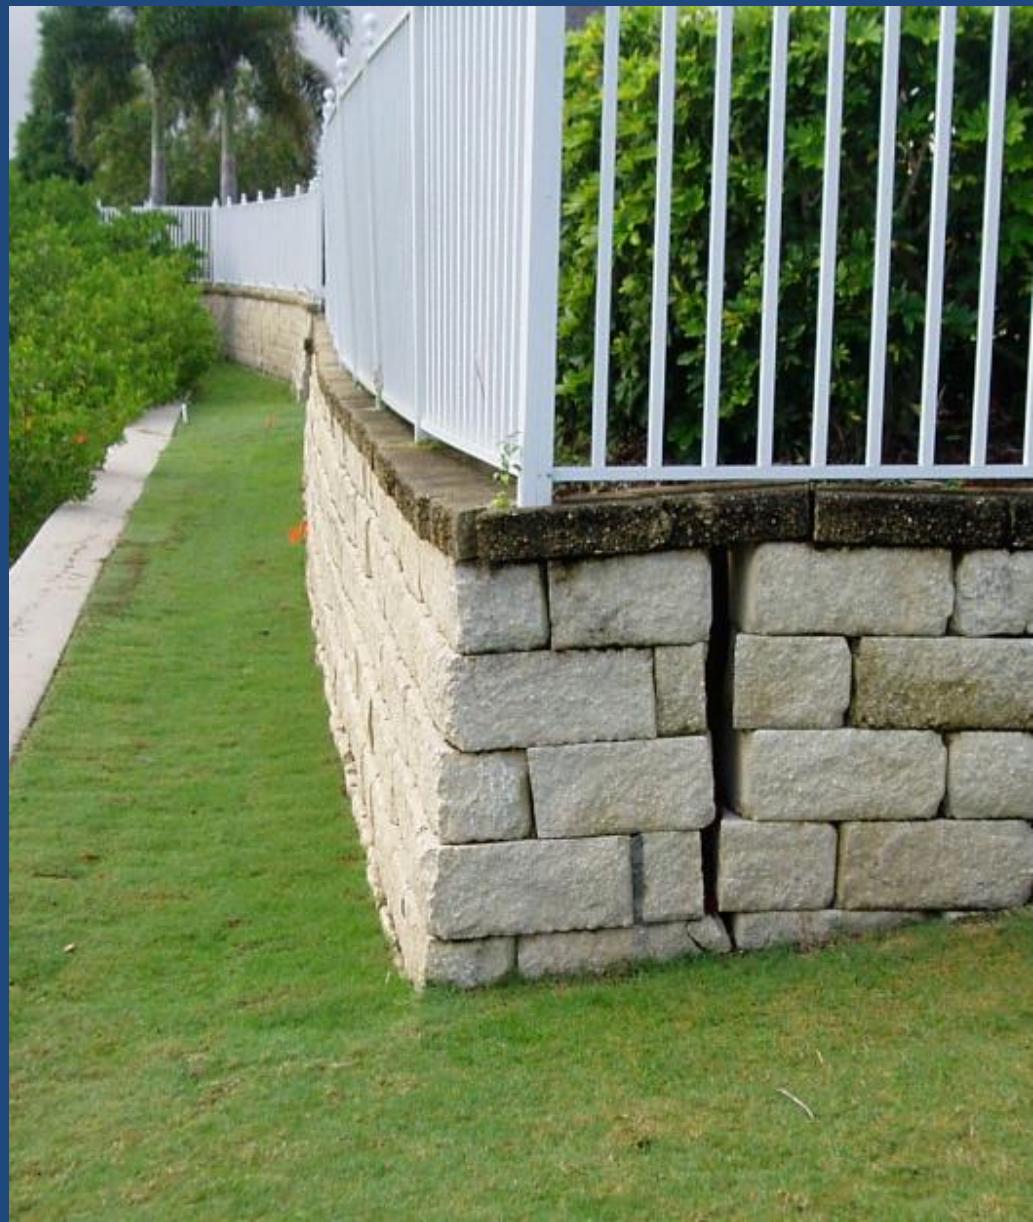
Patio/Yard Settlement Issues

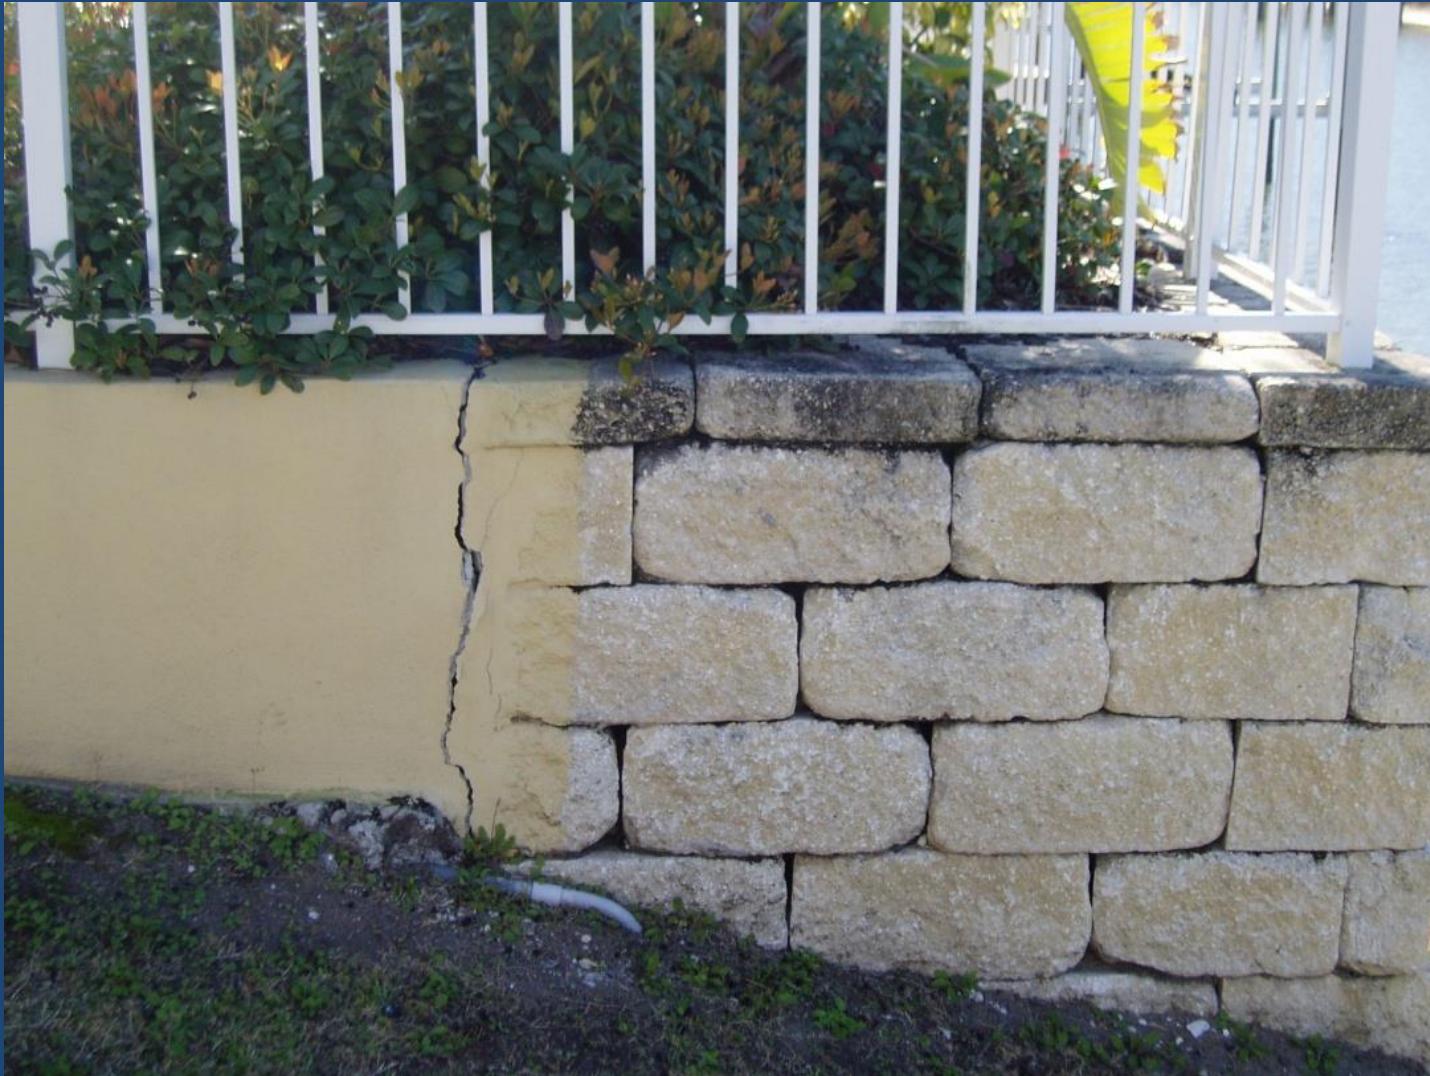
SETTLEMENT

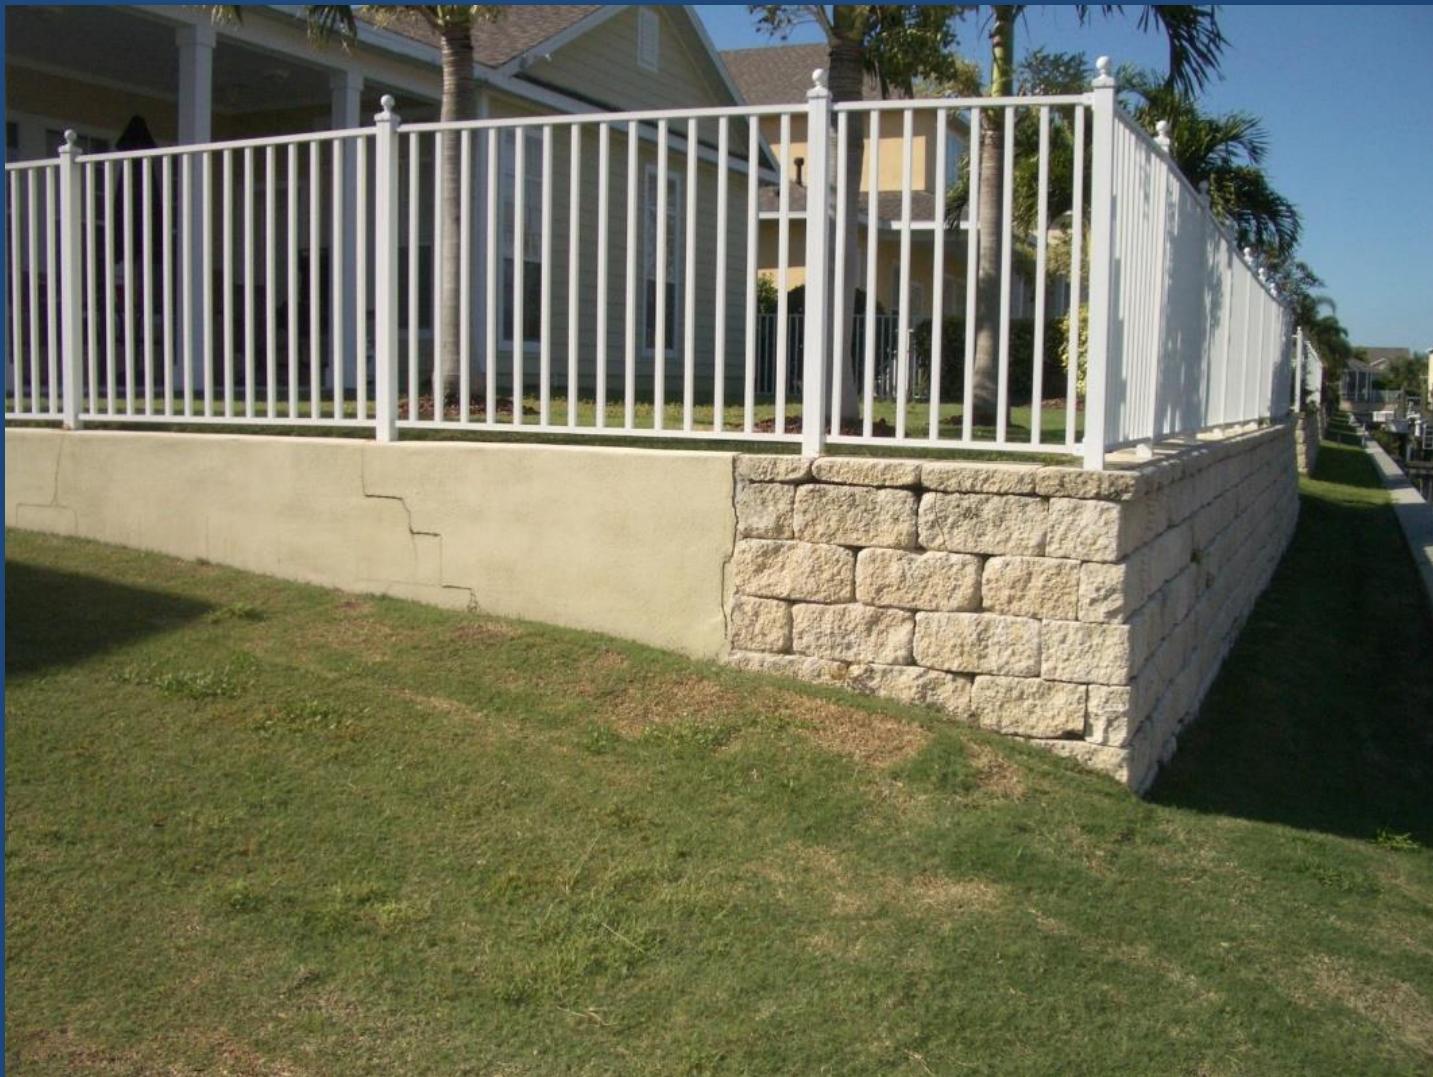
SETTLEMENT

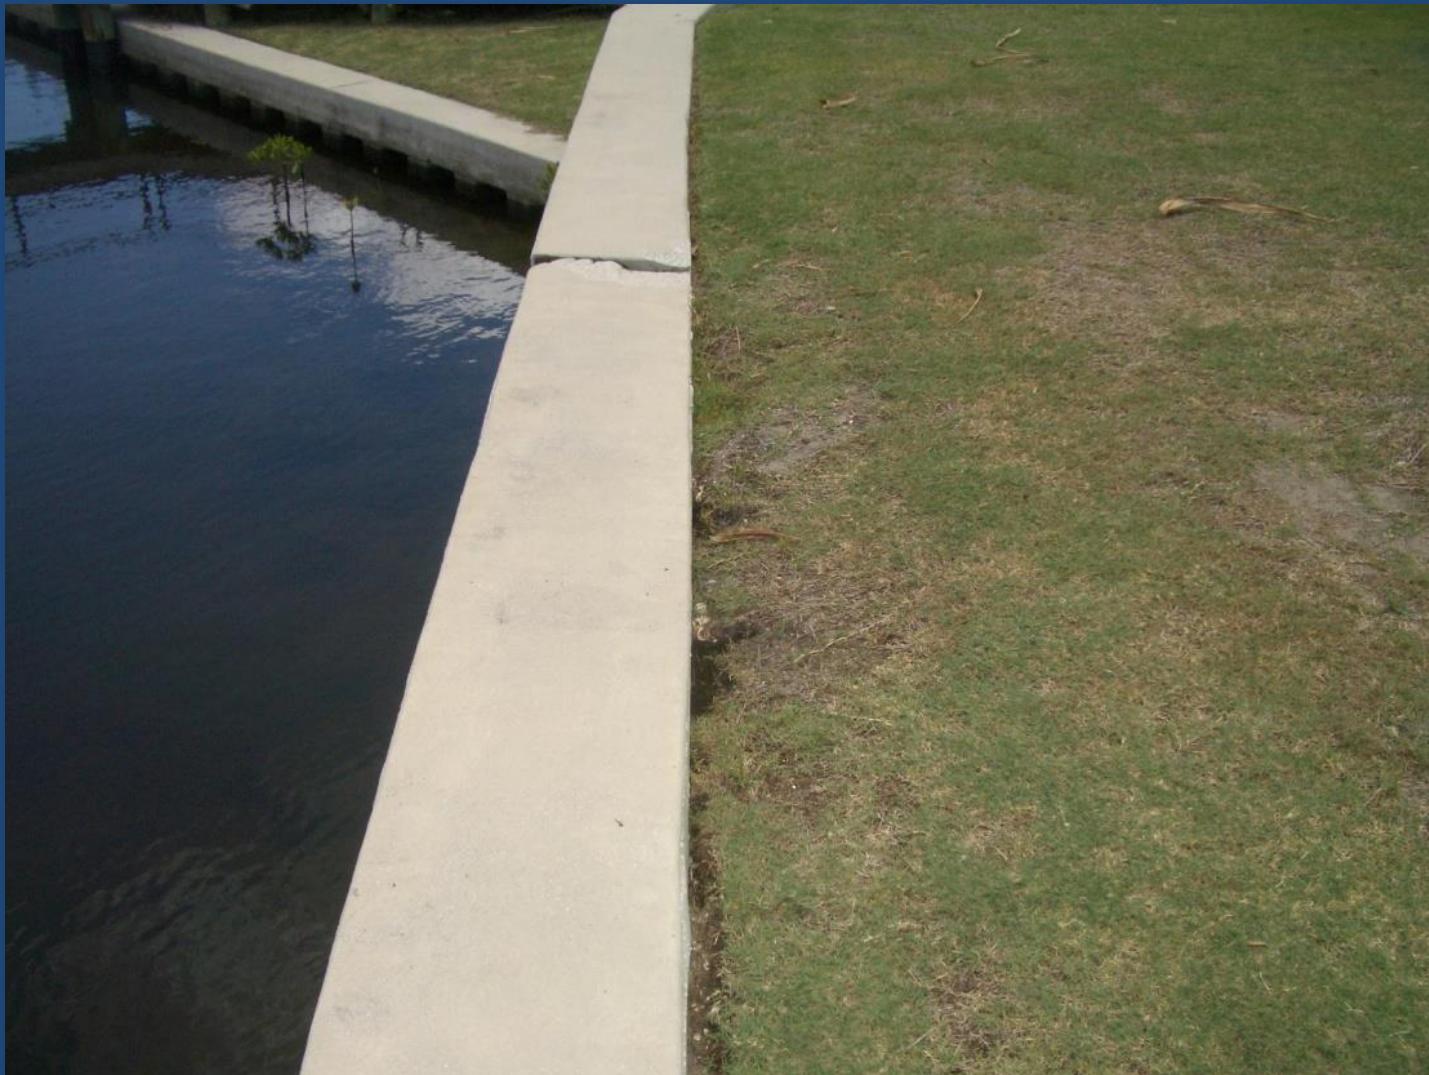
SETTLEMENT OF THE SOILS

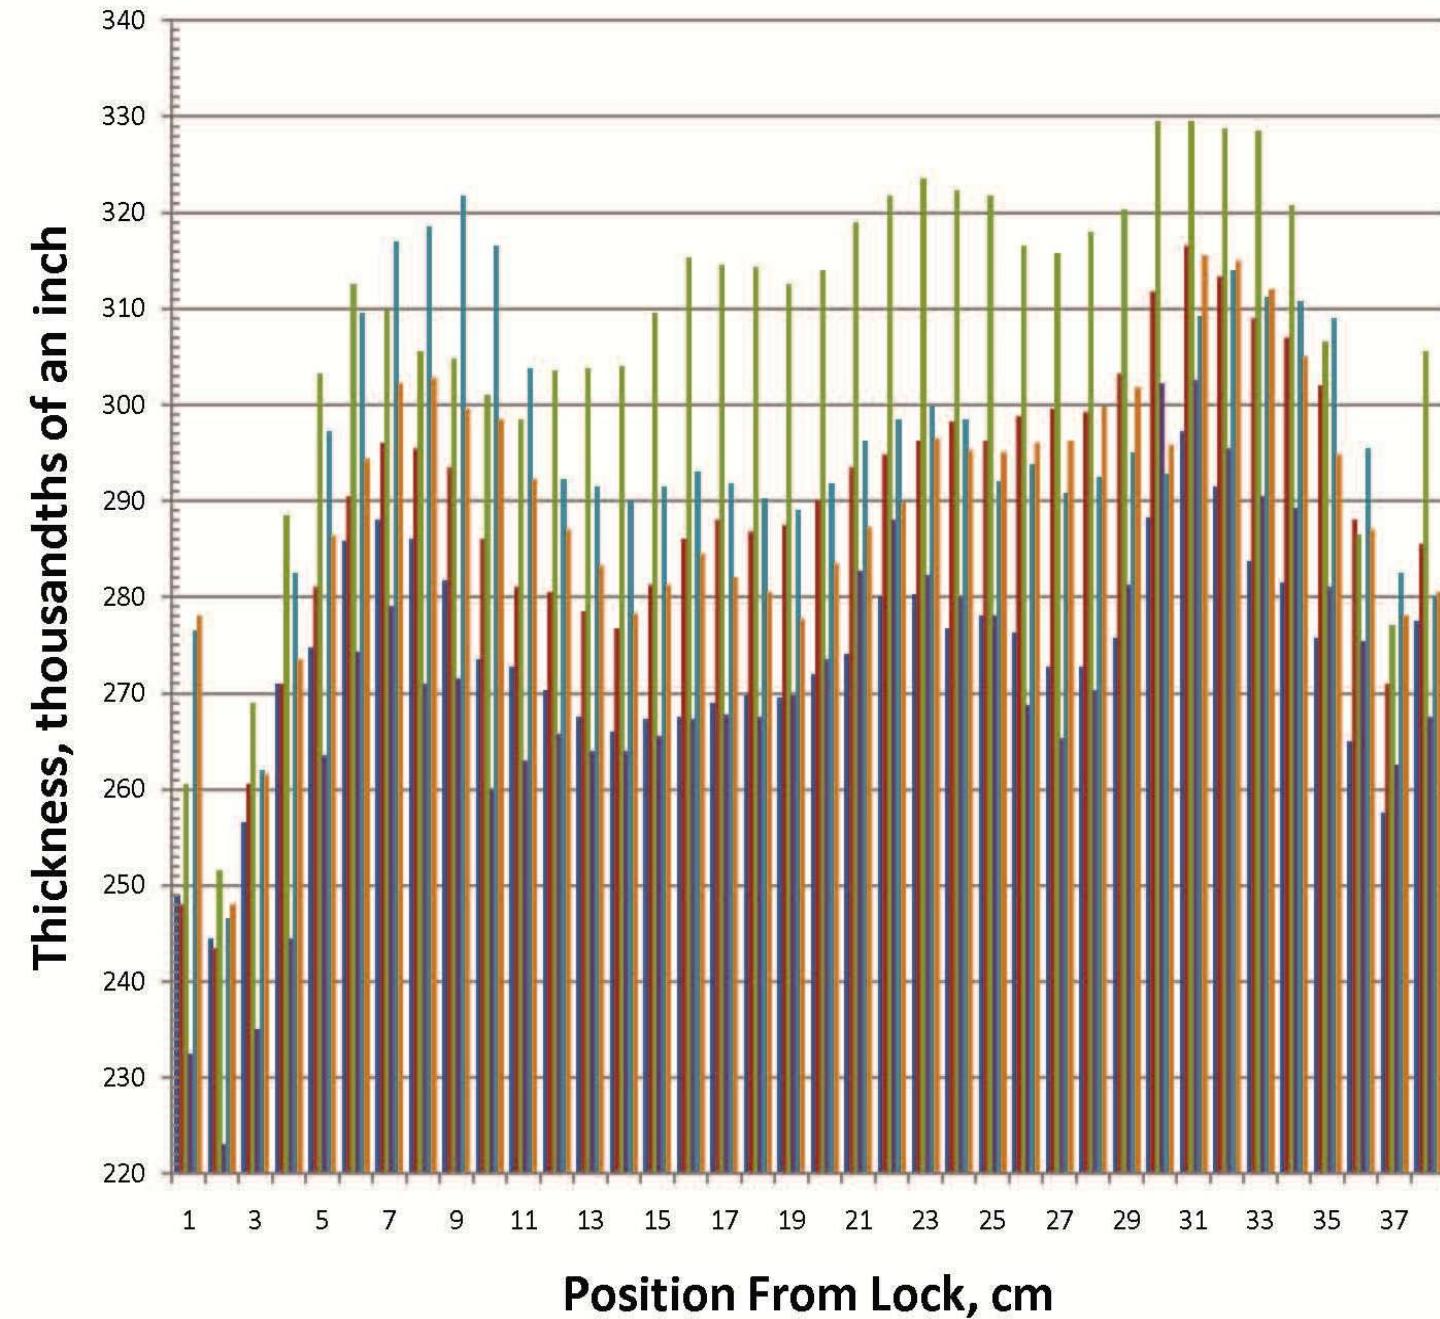
Thickness Values For Six Sets of Panels

VINYL MATERIAL ISSUES
