Soil Piping under Seawall

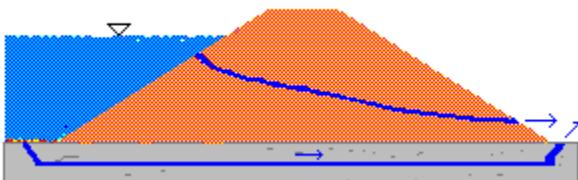
What piping look like. This can apply to any type of dam.

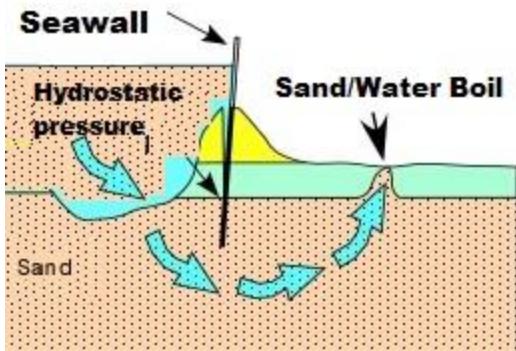
Coming back to the mysterious soil migration—a problem last year but gone this year—let's consider one possible cause. We know the soil has migrated somewhere since there have been so many holes needing filling. One phenomenon is known as piping and/or boiling. So how did the former Engineer see this in our canal? Well the canals were dry while they built out these walls. During the build out, Tampa went through some very wet years and the water buildup behind the walls was so great and the hydrostatic pressure built up so much that piping and boiling occurred. I asked what steps were taken to fix the design to correct this, I was told *none that he knew of*. Why do I go back to this? Recently a resident let me know that their upland holes were filled in with a lot of sand. Those holes are now back and deeper than before. The engineers say it is going into the bend, yet the last few measurements show almost no movement of the cap suggesting no further bowing of the wall. The question becomes where is it going?

Boiling as observed by the Engineer prior to the canals being flooded

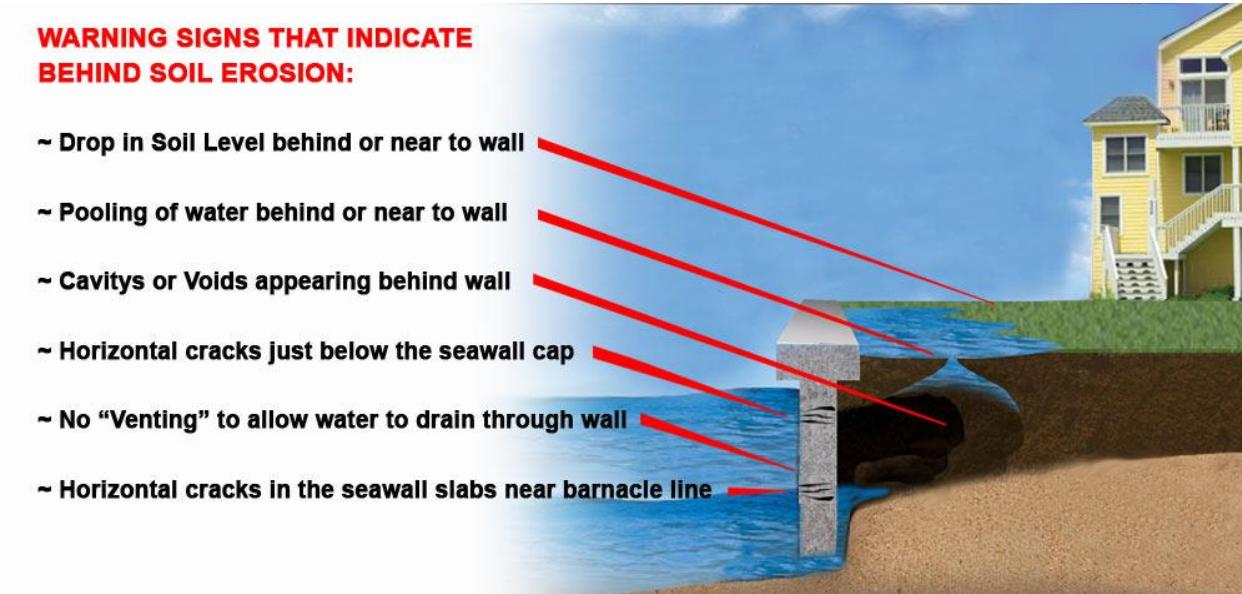
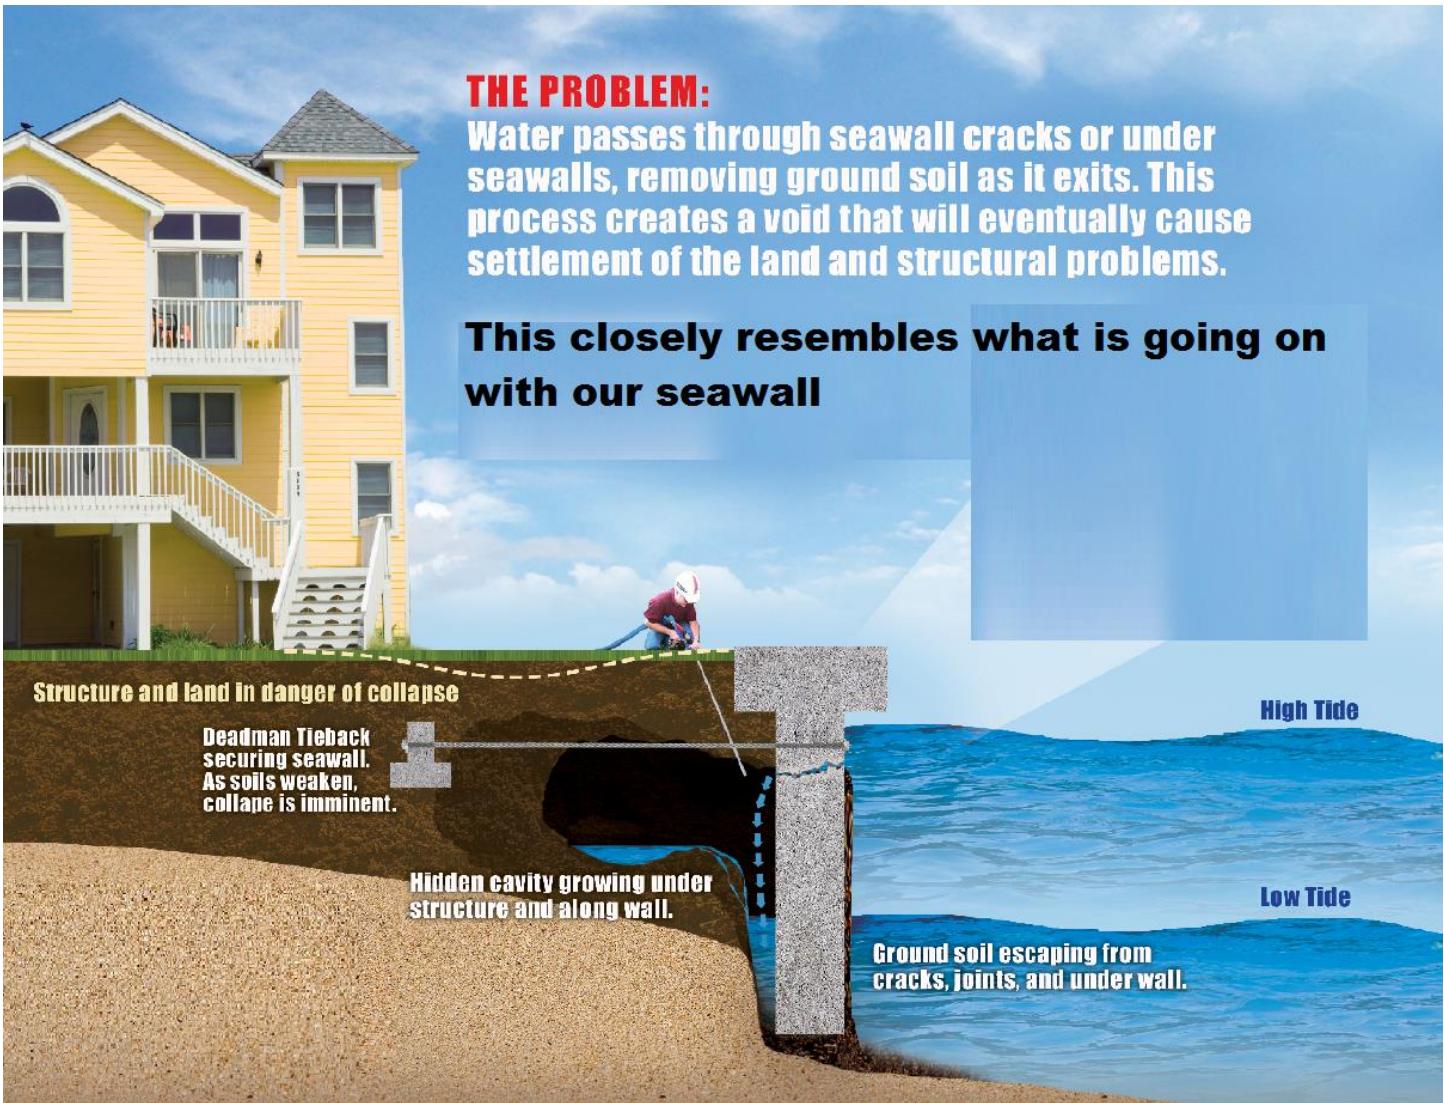
Soil erosion, (What is happening to our walls)

- ~ Drop in Soil Level behind or near to wall
- ~ Pooling of water behind or near to wall
- ~ Cavitys or Voids appearing behind wall
- ~ Horizontal cracks just below the seawall cap
- ~ No "Venting" to allow water to drain through wall
- ~ Horizontal cracks in the seawall slabs near barnacle line
