11 July 2017

**Re: Summary Report of Existing Sheet Pile Length Probe Testing
East Side of Community-Section I
Mirabay Development
Apollo Beach, Florida
Langan Project No.: 300117702**

Project
**MIRABAY DEVELOPMENT
 BULKHEAD
 RECONSTRUCTION PROJECT**
 APOLLO BEACH FL

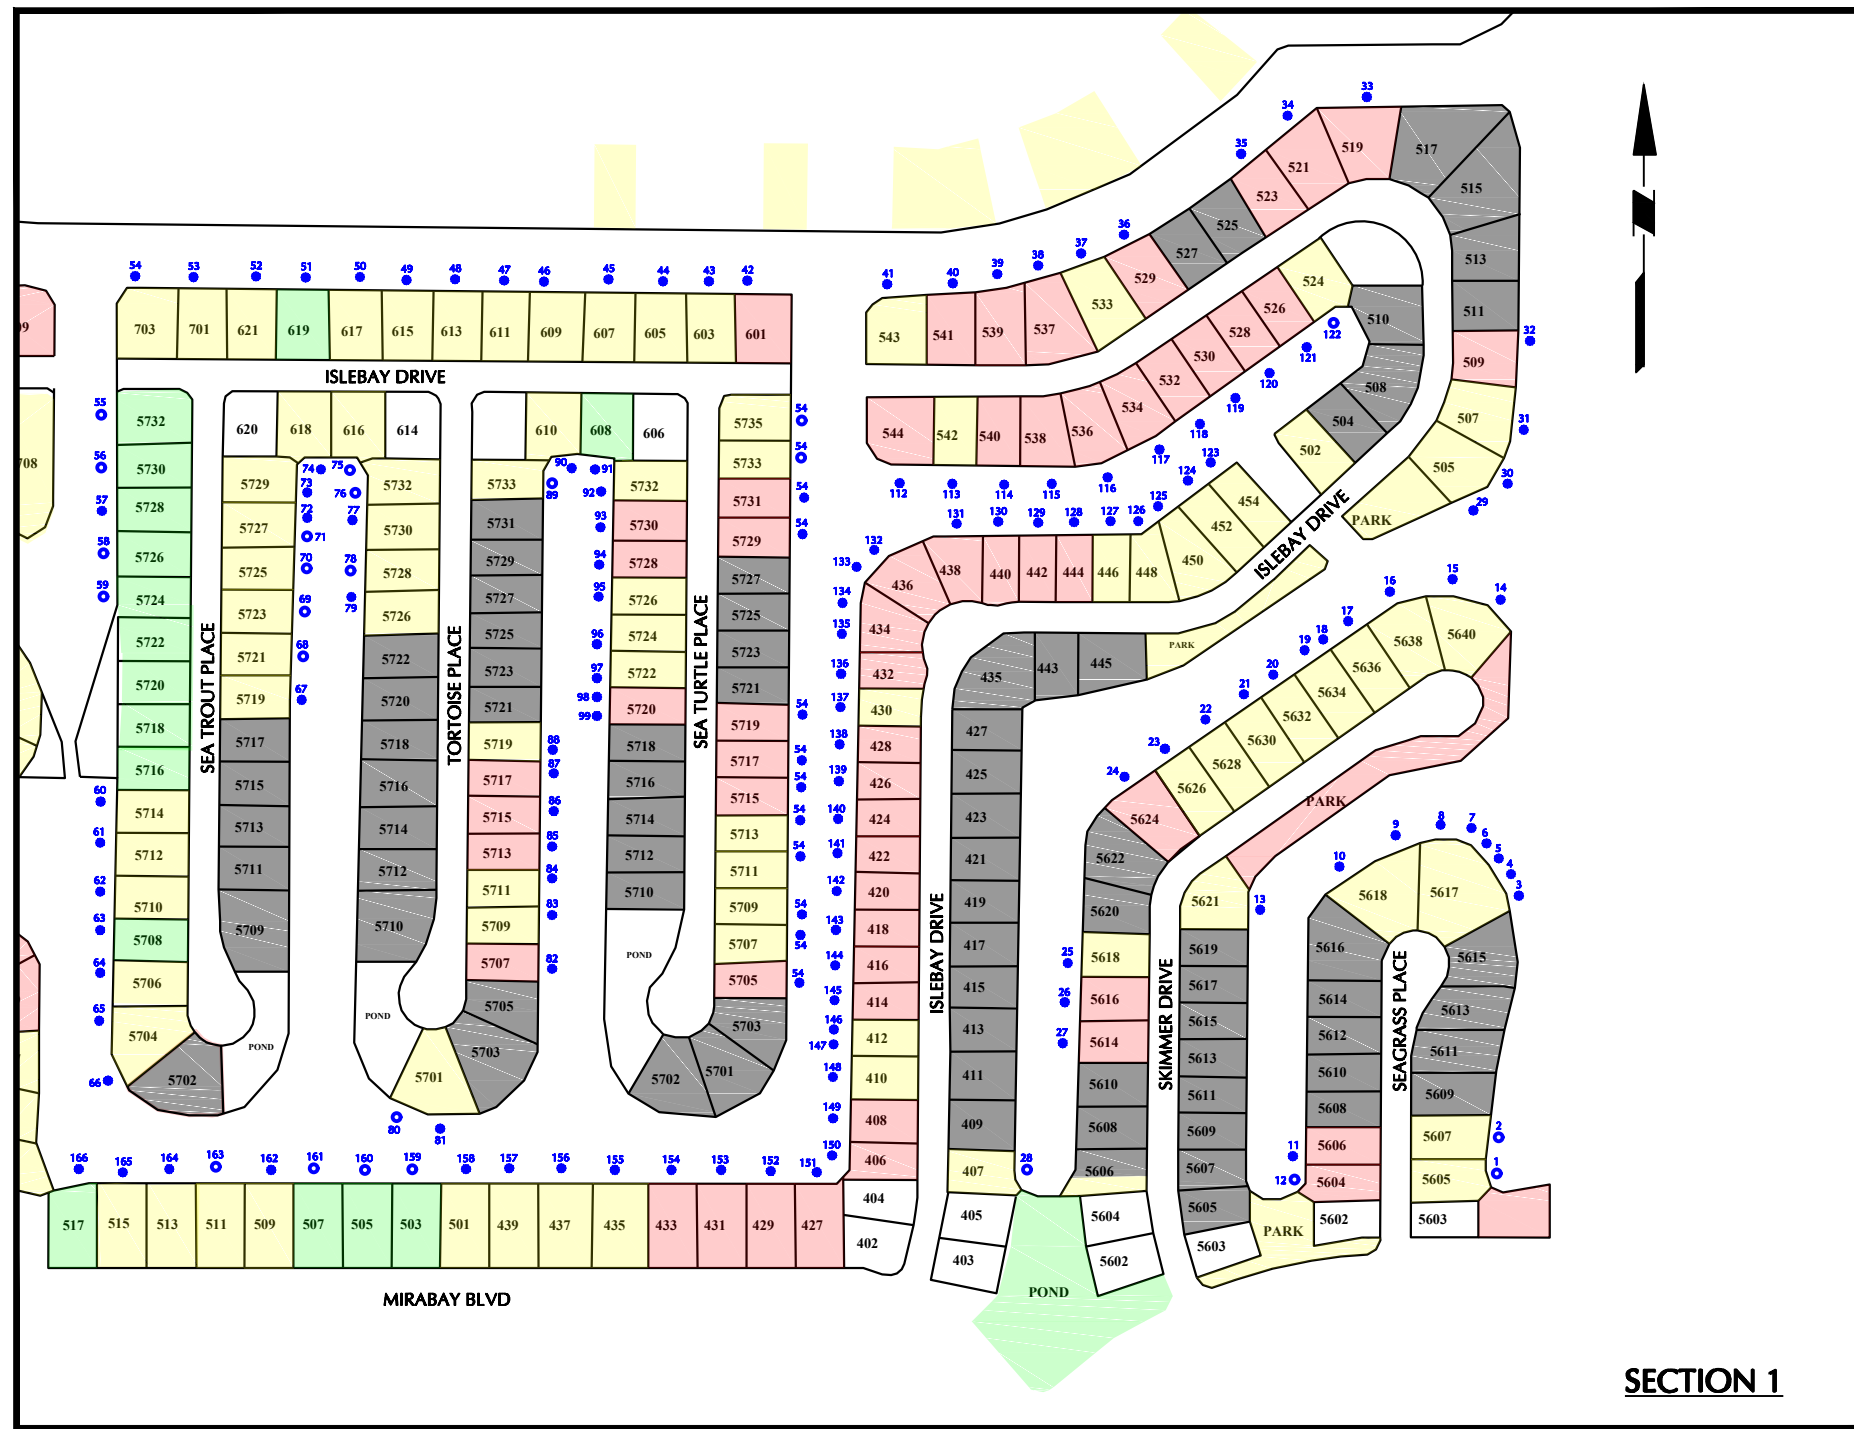
Project No. 300117702	Figure No.
Date 28 JUNE 2017	2
Scale 1" = 300'	
Drawn By CM	
Checked By JM/RA

Langan performed probe tests from 15 May 2017 through 19 May 2017 (refer to Figure No. 2 – Original Sheet Pile Embedment Depth Probing Location Plan). A total of 166 probe test locations were performed or attempted. Langan probed the bottom of the existing sheet piles at every lot throughout Section I of the community as shown on Figure 1. Selective additional probe testing was performed where there was 1) deepened waterside berm, 2) significant cap rotation deflections, and 3) significant soil loss immediately landside of the bulkhead cap.

The shortest probed sheet pile depths, at about el -4, are localized and occurred at only four of the points tested. Additional extensive probing was performed at 5617 Seagrass Place. This is the location where a 4 ft stretch of sheet piling with tip elevations at about el -1.5 was observed. The tip of the sheet pile at the six probe points performed at this lot was determined to be at el -6 indicating the shorter sheet zone was localized.

As indicated on the plan, there were stretches of bulkhead where the probe testing was impeded by thick mangrove growth or cemented waterside berm surfaces ("oyster shells"). These non-probed zones are not indicative of sheet pile lengths shorter than the original design intent rather just interference to the manual probing technique.

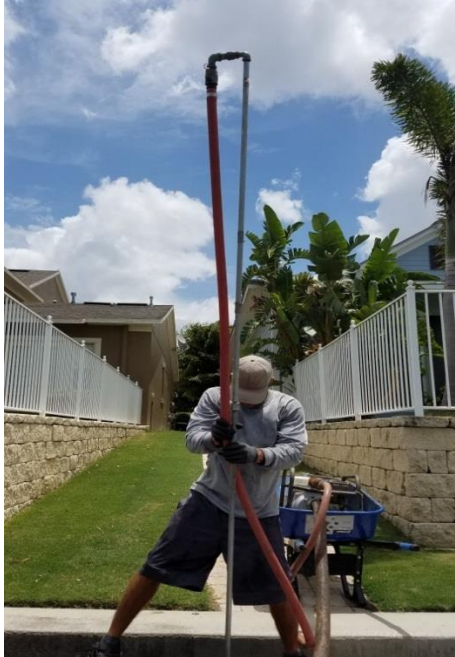
Photo No. 4 – Advance of probe by hydraulic jetting.

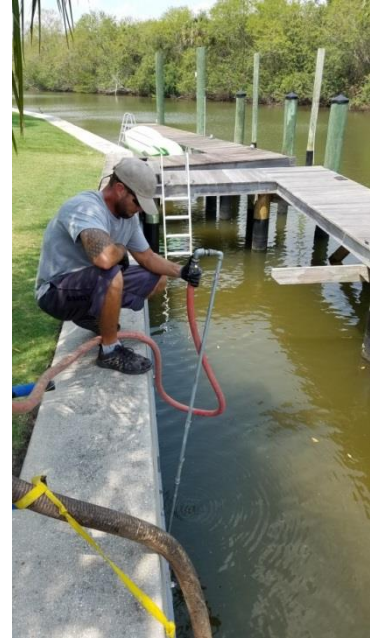
Photo No. 5 – Advance Hook Below el -6.

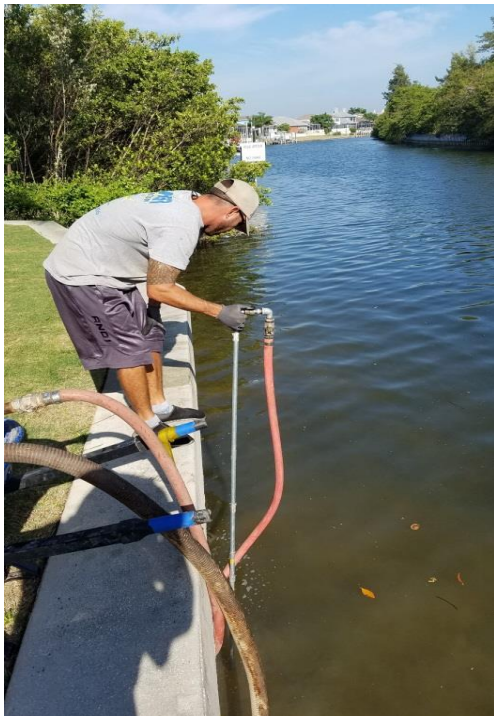
Photo No. 6 – Probe advanced at incline under sheet pile.

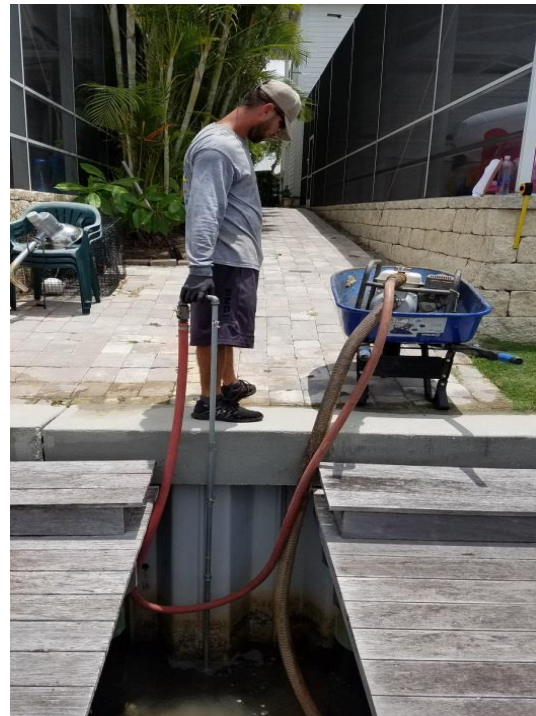
Photo No. 7 – Probe retrieved from under sheet pile to infer embedded sheet pile tip.
