## MEMORANDUM

**TO:** Harbor Bay Community Development District  
**FROM:** Christopher Gamache, PE  
**DATE:** 9/14/2017  
**RE:** Isolated Seawall Assessments

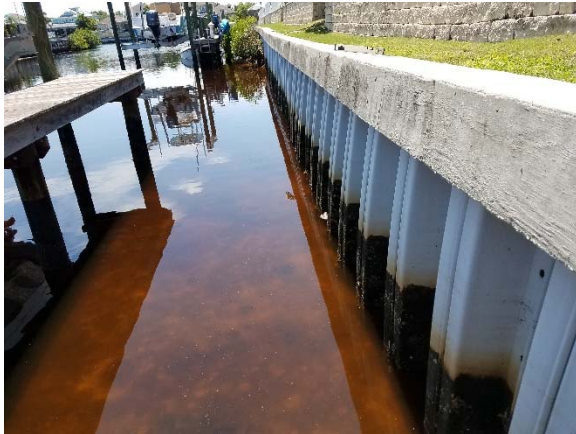
### 5713 Tortoise Place

In general, additional wall movements/rotations were noted at the properties observed. The movements/rotations are believed to be caused by the conditions produced by hurricane Irma. The hurricane simultaneously reduced the restraining pressure on the seawall by draining water out of the canal and increased the backfill pressure with excessive rainfall that was trapped behind the wall due to non-functioning existing weep holes.

Additional cap rotation was observed.  
Max cap rotation was measured at 9.1°.  
Minor voids were present behind the cap.

Recommendation:  
An emergency retrofit is recommended. New weep holes should be installed to relieve water pressure behind the wall.

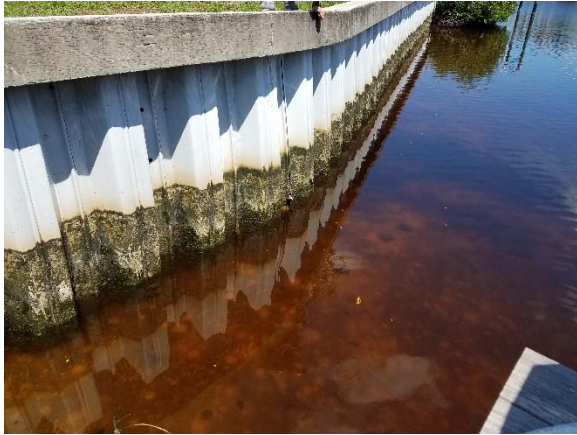
### 536 Islebay Drive

Additional cap rotation was observed.  
Max cap rotation was measured at 7.3°.  
Minor voids were present behind the cap.

No action at this time. The wall should remain on the priority list.

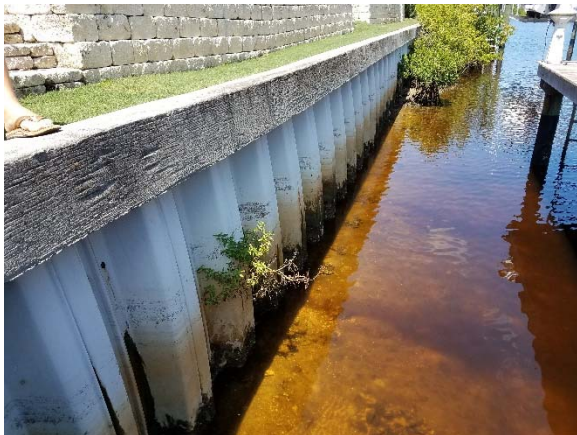
### 5705 Sea Turtle Place

Additional cap rotation was observed.  
Max cap rotation was measured at 9.1°.  
Minor voids were present behind the cap.  
Scour troughs were noted in the canal perpendicular to the wall.

An emergency retrofit is recommended. New weep holes should be installed to relieve water pressure behind the wall.

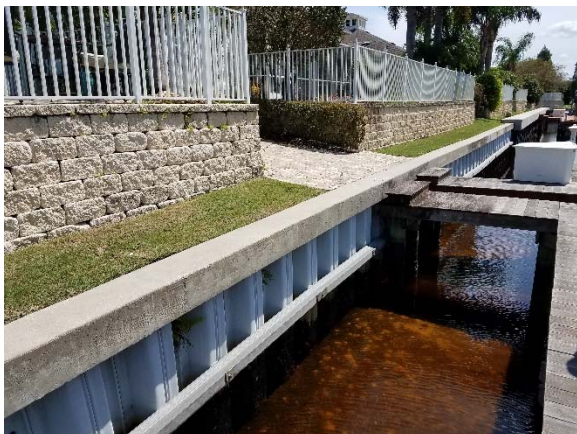
### 5614 & 5616 Skimmer Drive

Significant changes were not noted.  
Minor voids were present behind the cap.

No action at this time. The wall should remain on the priority list.

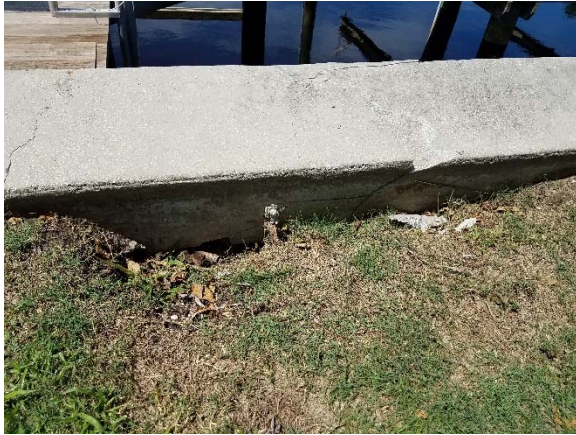
### 5624 Skimmer Drive

Additional cap rotation was observed. Max cap rotation was measured at 9.9°. Large voids were present behind the cap. The cap has twisted and fractured near the southern end of the property.

An emergency retrofit is recommended. New weep holes should be installed to relieve water pressure behind the wall. Voids should be backfilled with free draining material.

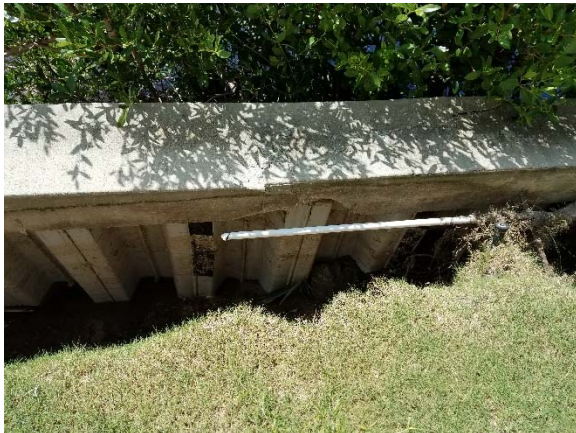
### 5606 Seagrass Place

Additional cap rotation was observed. Max cap rotation was measured at 10.7°. Backfill has migrated under the toe of the wall leaving large full height voids behind the wall. The cap has twisted and fractured near the middle of the property.

An emergency retrofit is recommended. New weep holes should be installed to relieve water pressure behind the wall. Rock or grout bags should be placed at the bottom of the voids prior to backfilling with free draining material.
