# NAVIGATION STUDY REPORT

## MiraBay Apollo Beach, Florida

**December 12, 2015**

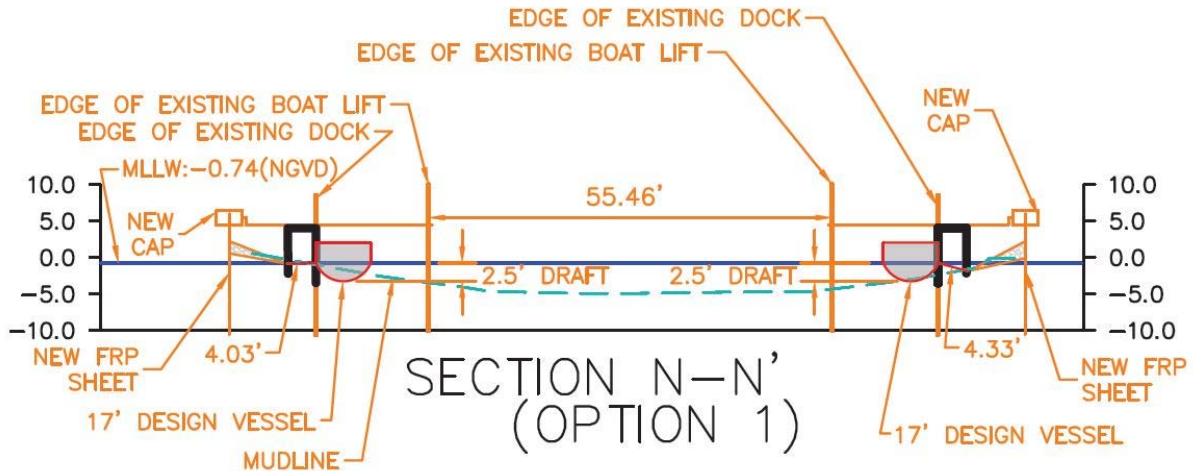
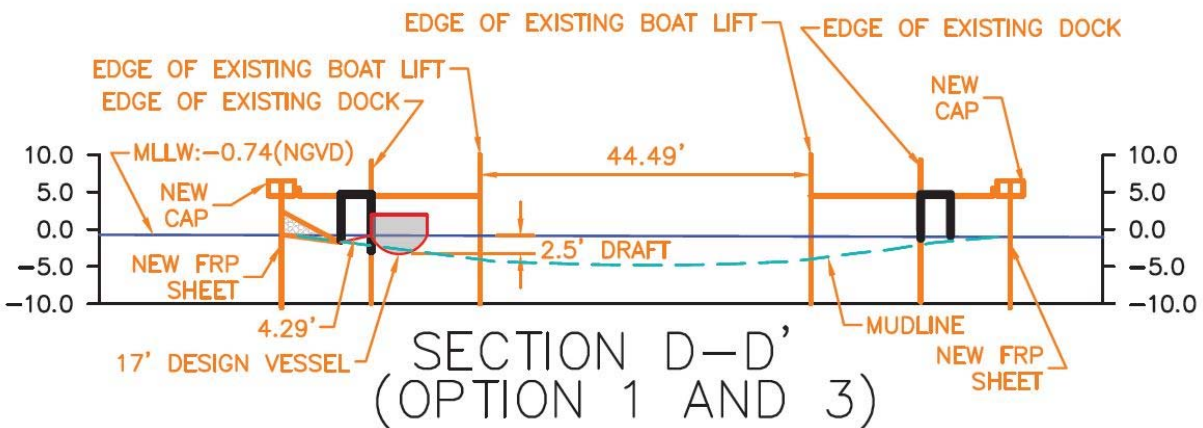
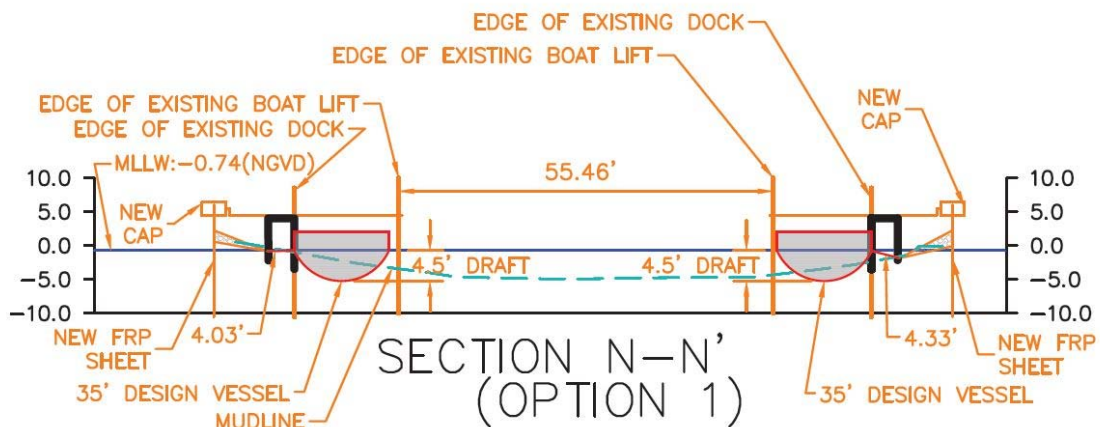
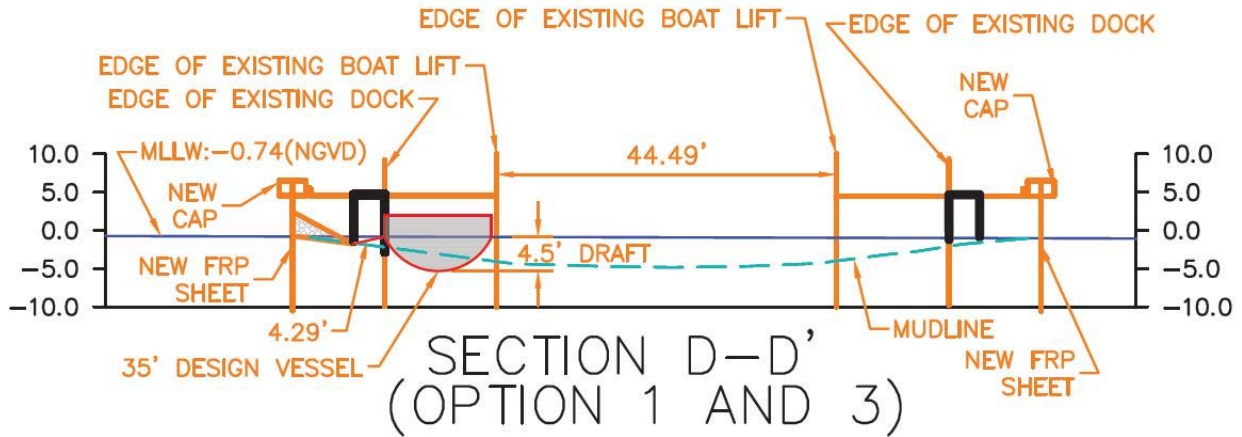
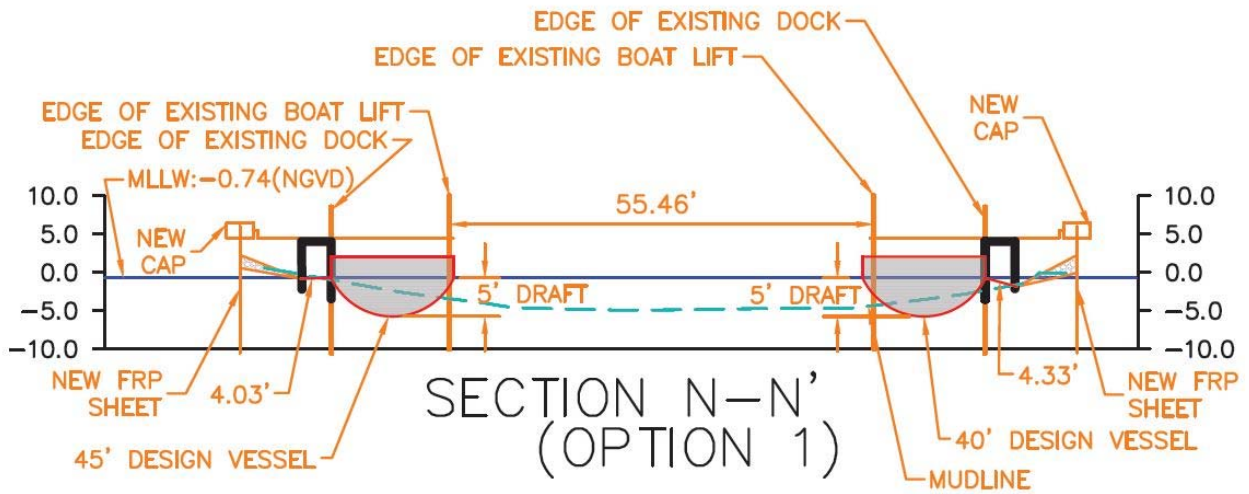
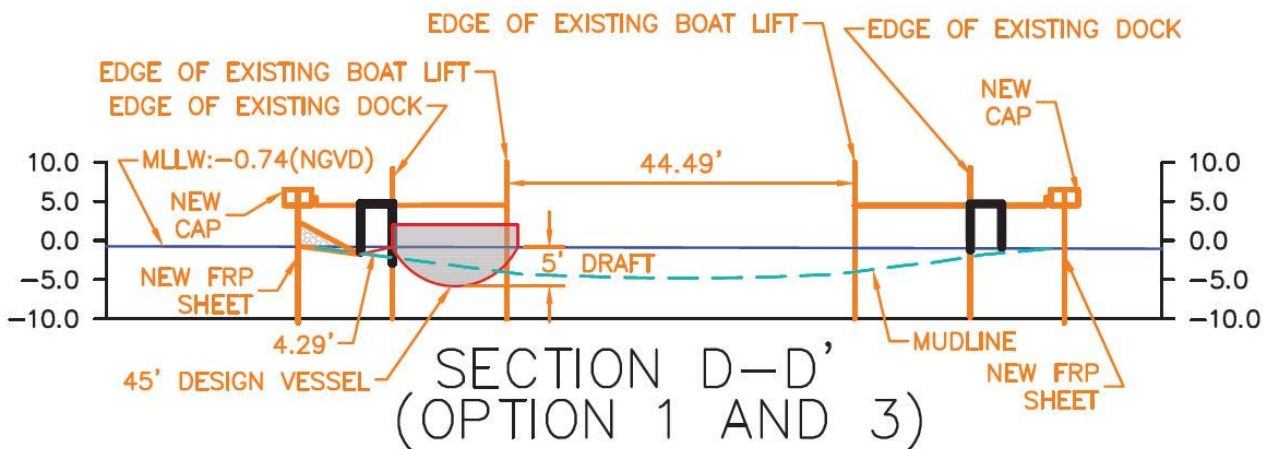
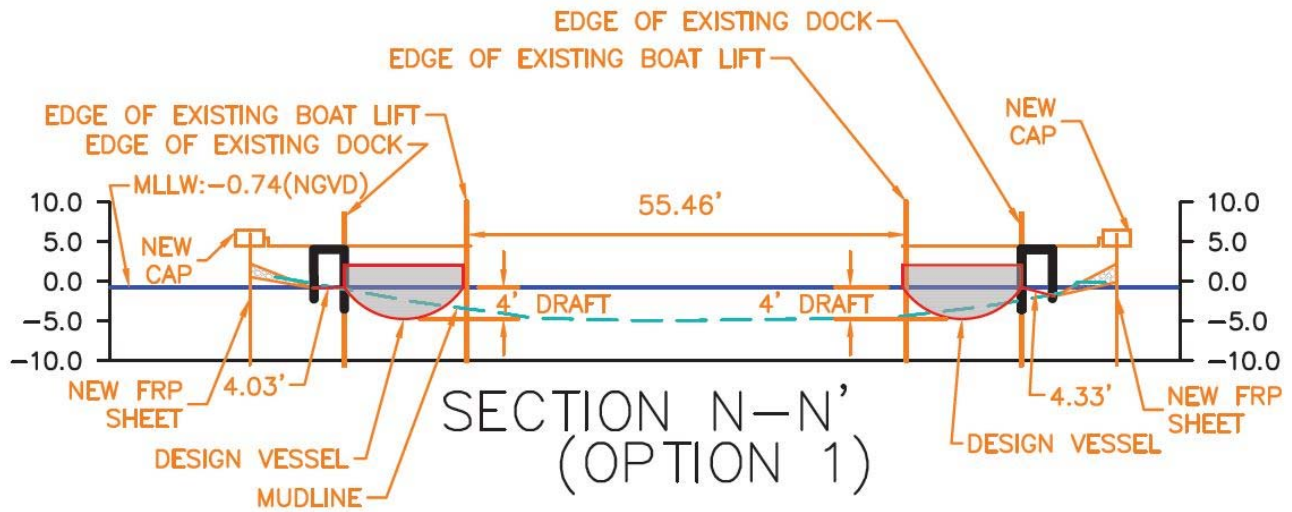
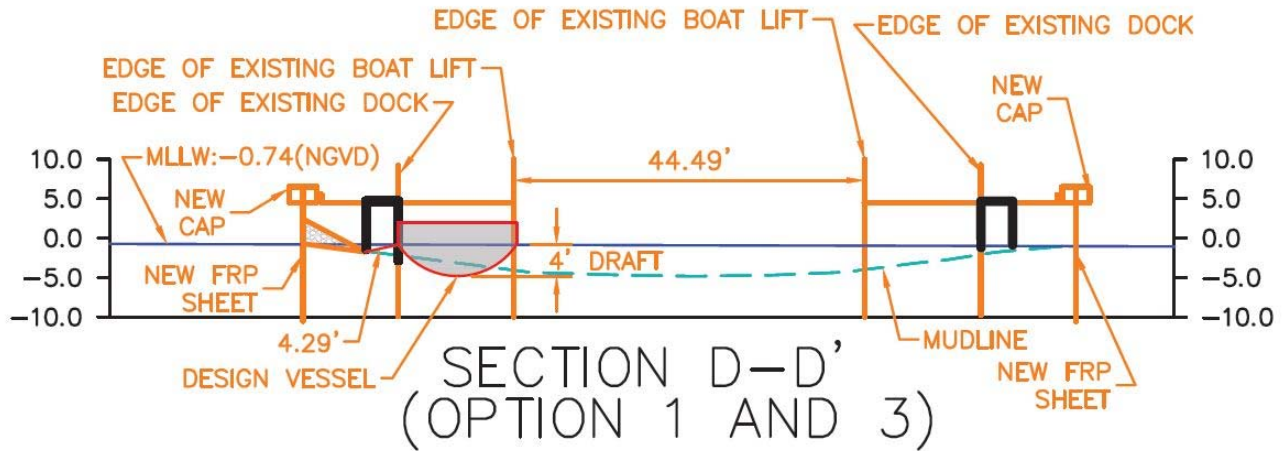
A number of cross section profiles have been prepared as follows that depict representative design vessels of varying size and draft. The vessel geometry shown in these profiles is used only for assessment purposes and is not intended to match that of any particular craft. As can be seen in these profiles, clearance distances exist beneath the vessels to the soft mudline less than the recommended 3 feet. However, the recommended minimum 3 foot clearance to the hard rip rap is satisfied since it would be placed no further than the back edge of the docks which measure roughly 4 feet wide.
