MIRABAY SEAWALL LITIGATION

- April 18, 2012

WHY IS IT TAKING SO LONG?

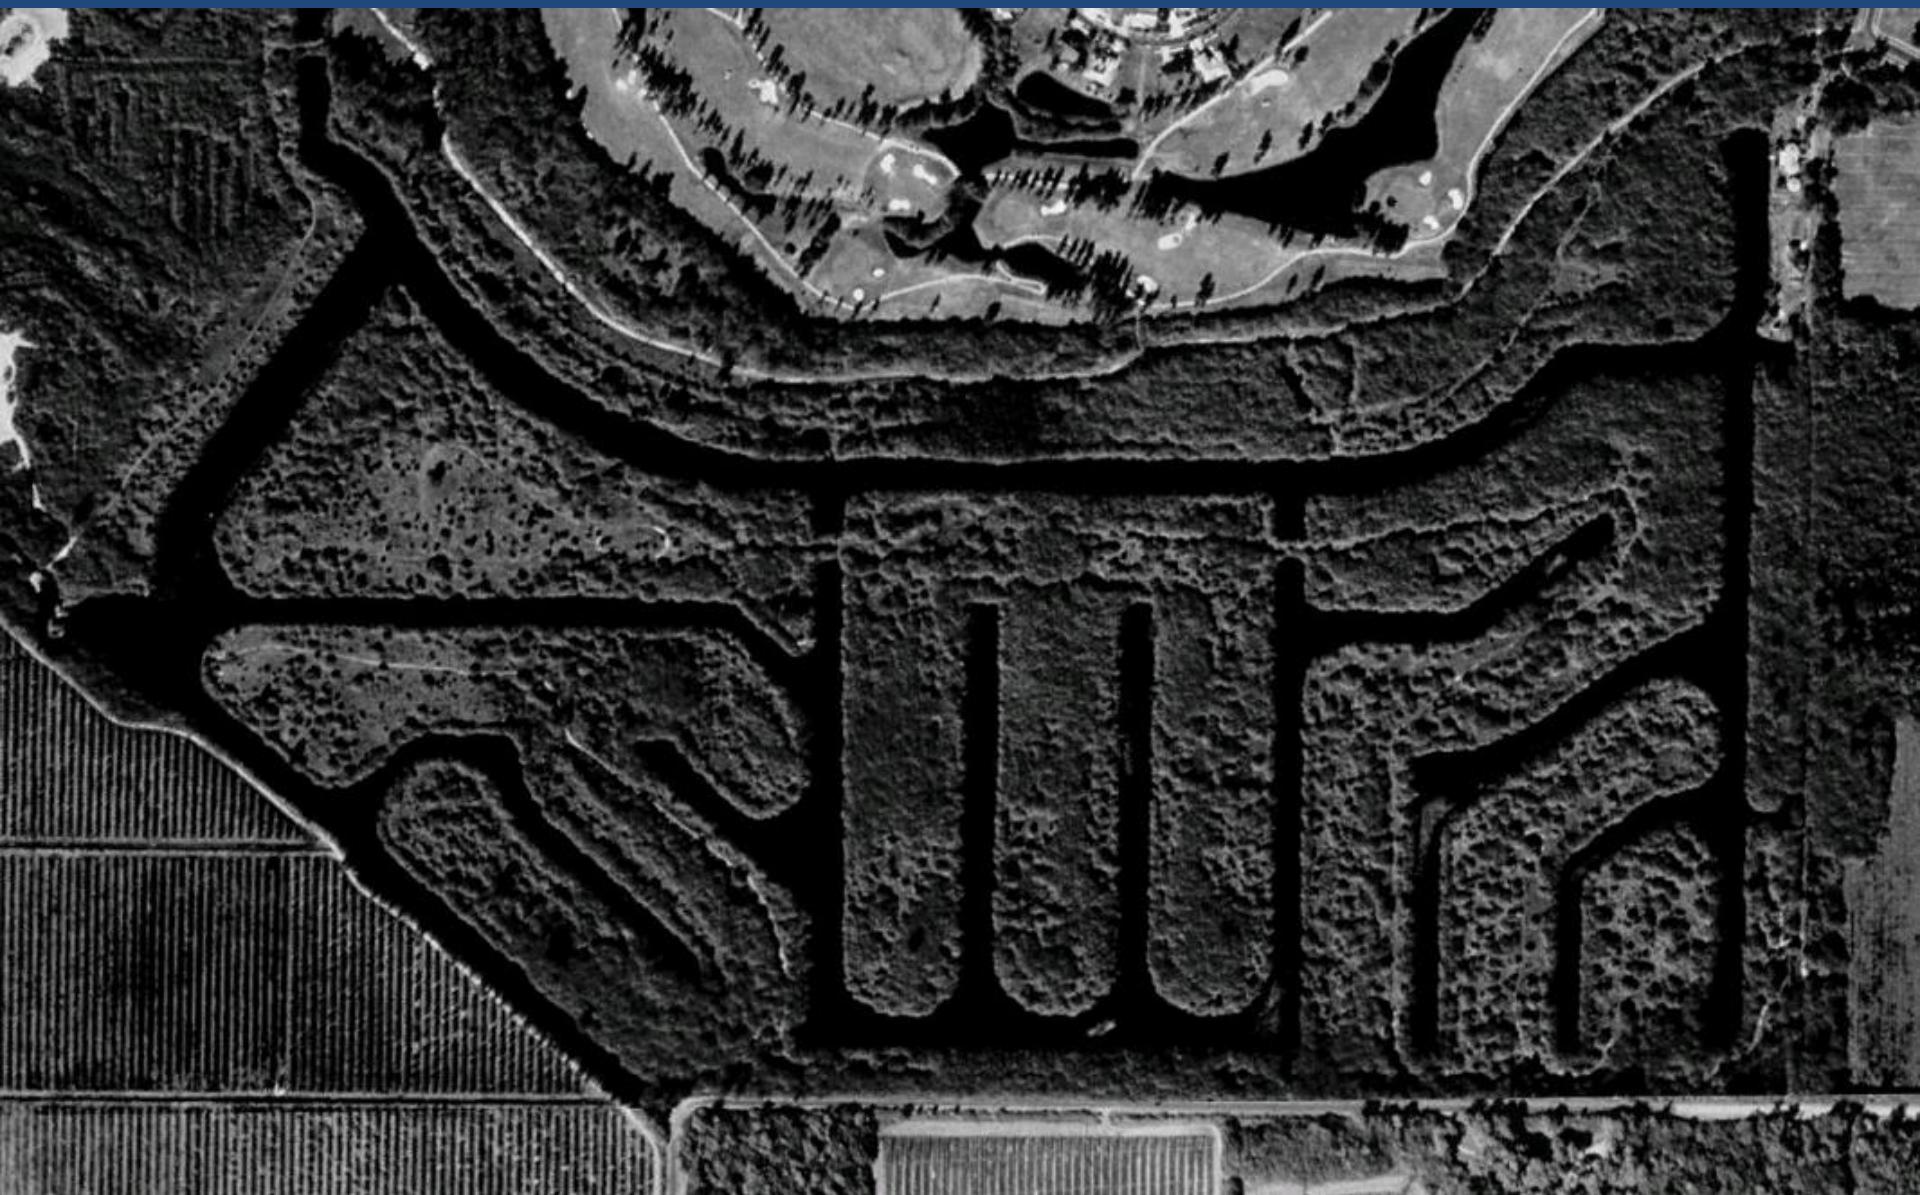
SITE IN 1998

1. Warning Historic Wetlands. We are about to build a major subdivision in a Coastal Marsh.
2. Become familiar with the soil conditions at this massive site. Dig test pits.
3. Many areas of the project will have unsuitable soils and this is a critical issue on this job.
4. Nothing about this site is homogeneous from a soils perspective.

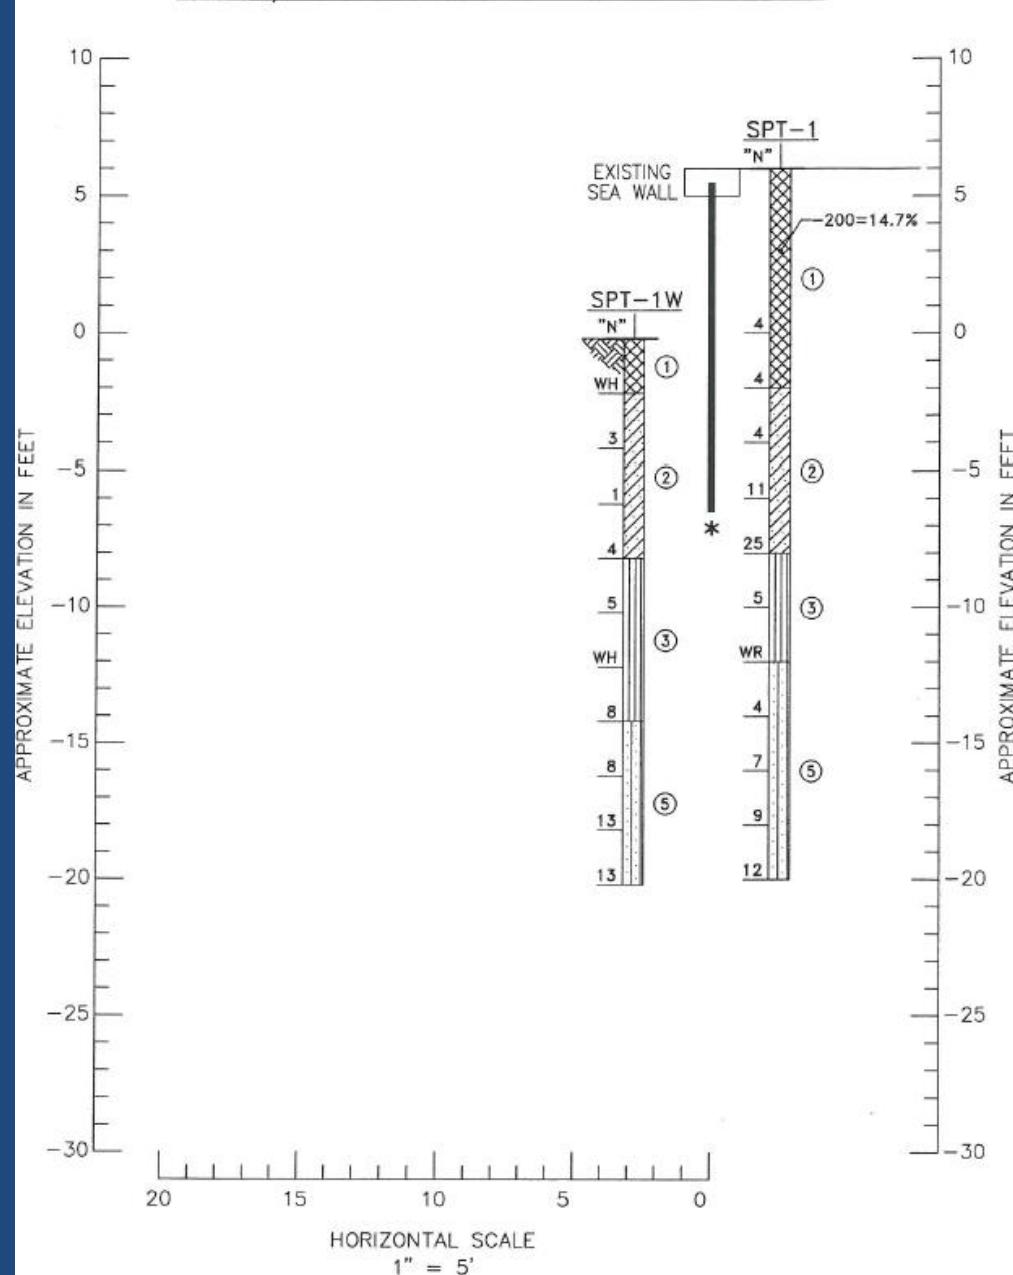
TYPICAL SOIL BORING RESULT

SOIL TESTS RESULTS

- 56 Grain Size Distribution Sieve Samples
 - 28.6% contained excess fines
- 93 Density Tests
 - 81% did not meet or exceed the density requirements
- 43 Standard Penetration Borings (within 5 feet of the seawall)
 - Average Penetration Resistance N Value: 6.87
 - Indicative of “Loose” soils
- 30 Standard Penetration Borings (from 10 feet from the seawall to center of lots)
 - Average Penetration Resistance N Value: 8.31
 - Indicative of “Loose” soils

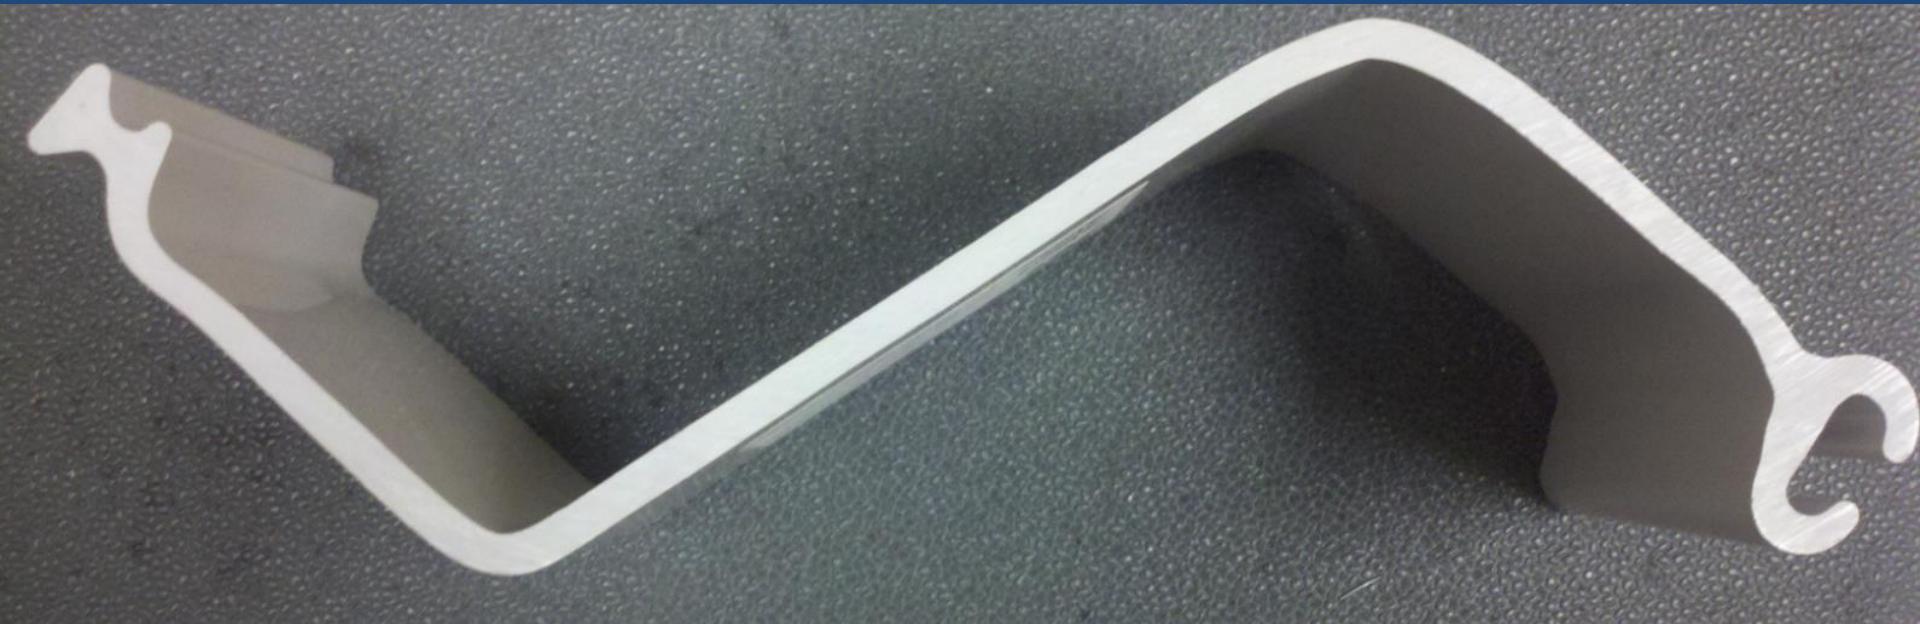
VINYL SHEET GEOMETRY

- Shoreguard Vinyl Sheet issues:
 - Substantial likelihood that the materials failed to have the requisite UV protectant
 - Inadequate and inconsistent product sheet thickness
 - Materials contained significant impurities
 - Failed to properly account for “creep”
 - Ambient temperatures not accounted for

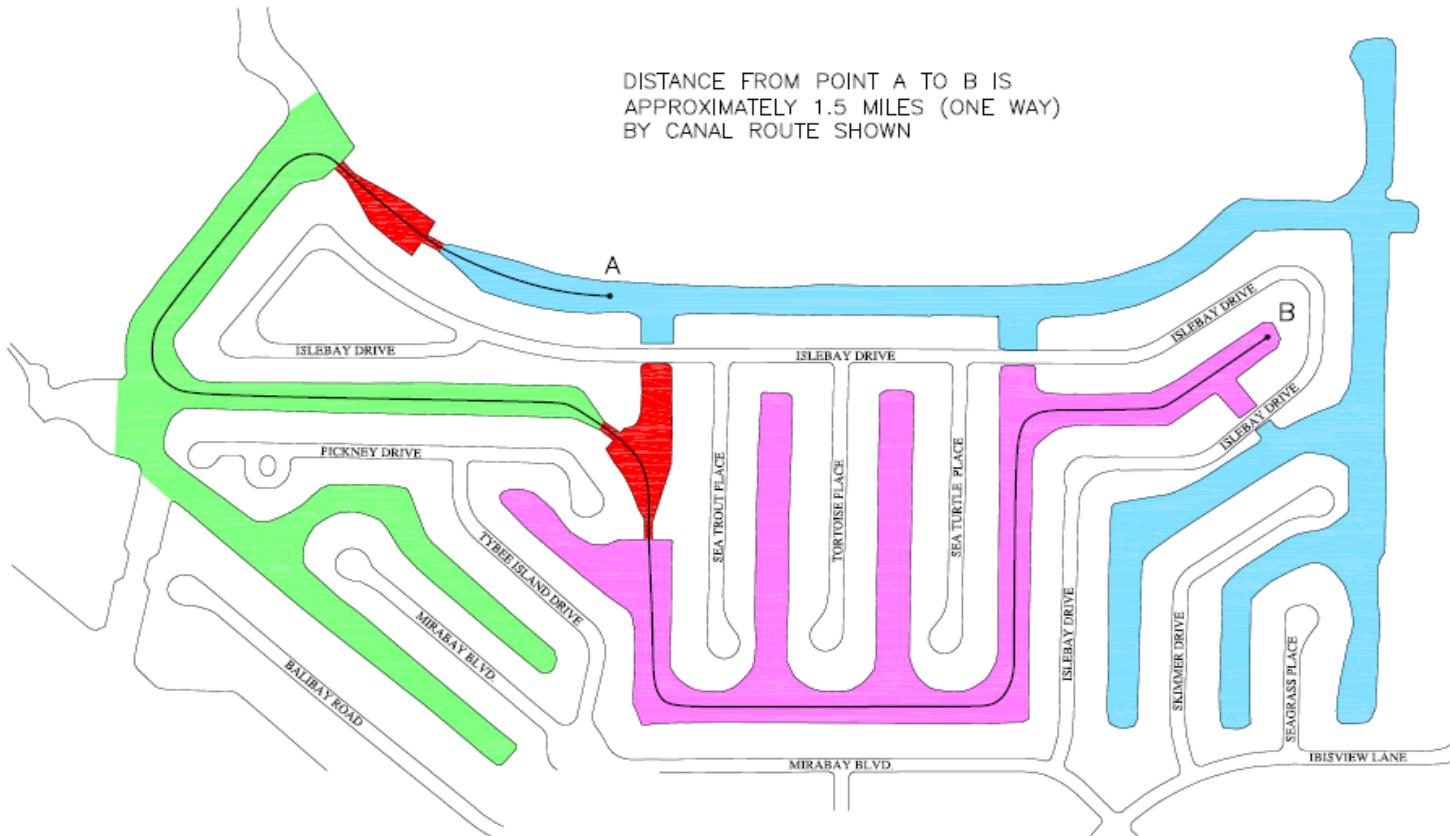
Complications With Repair

EXAMPLE OF MATERIAL BARGE TRANSPORT DISTANCE
